**Draft Options Appraisal
for
Nocton Hall, Lincolnshire.**

Client NKDC: October 2011

**© Anderson & Glenn: Conservation Architects
Boston, PE20 1RQ: Telephone 01205 724047**

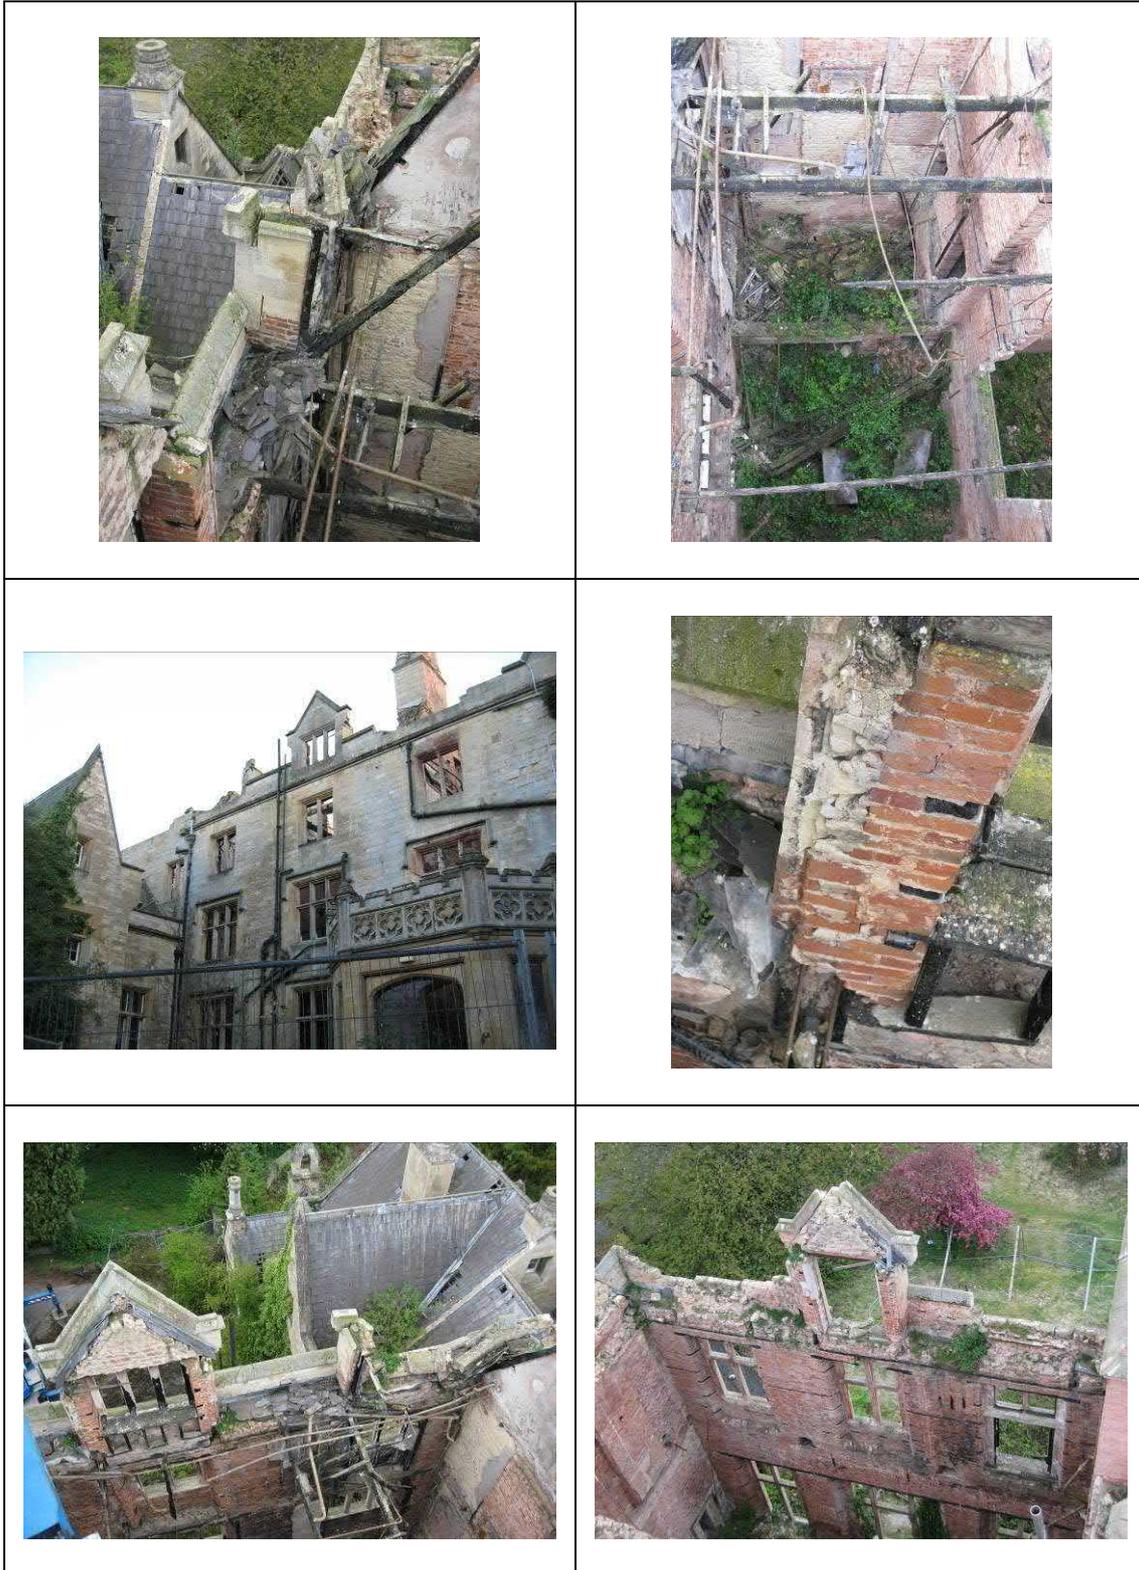
Plate 3:

Top row: *Pipe and other metal work left hanging after the fire in 2010.*

Centre & Bottom Rows: *Urgent repairs needed to stabilize dormers in 2010.*

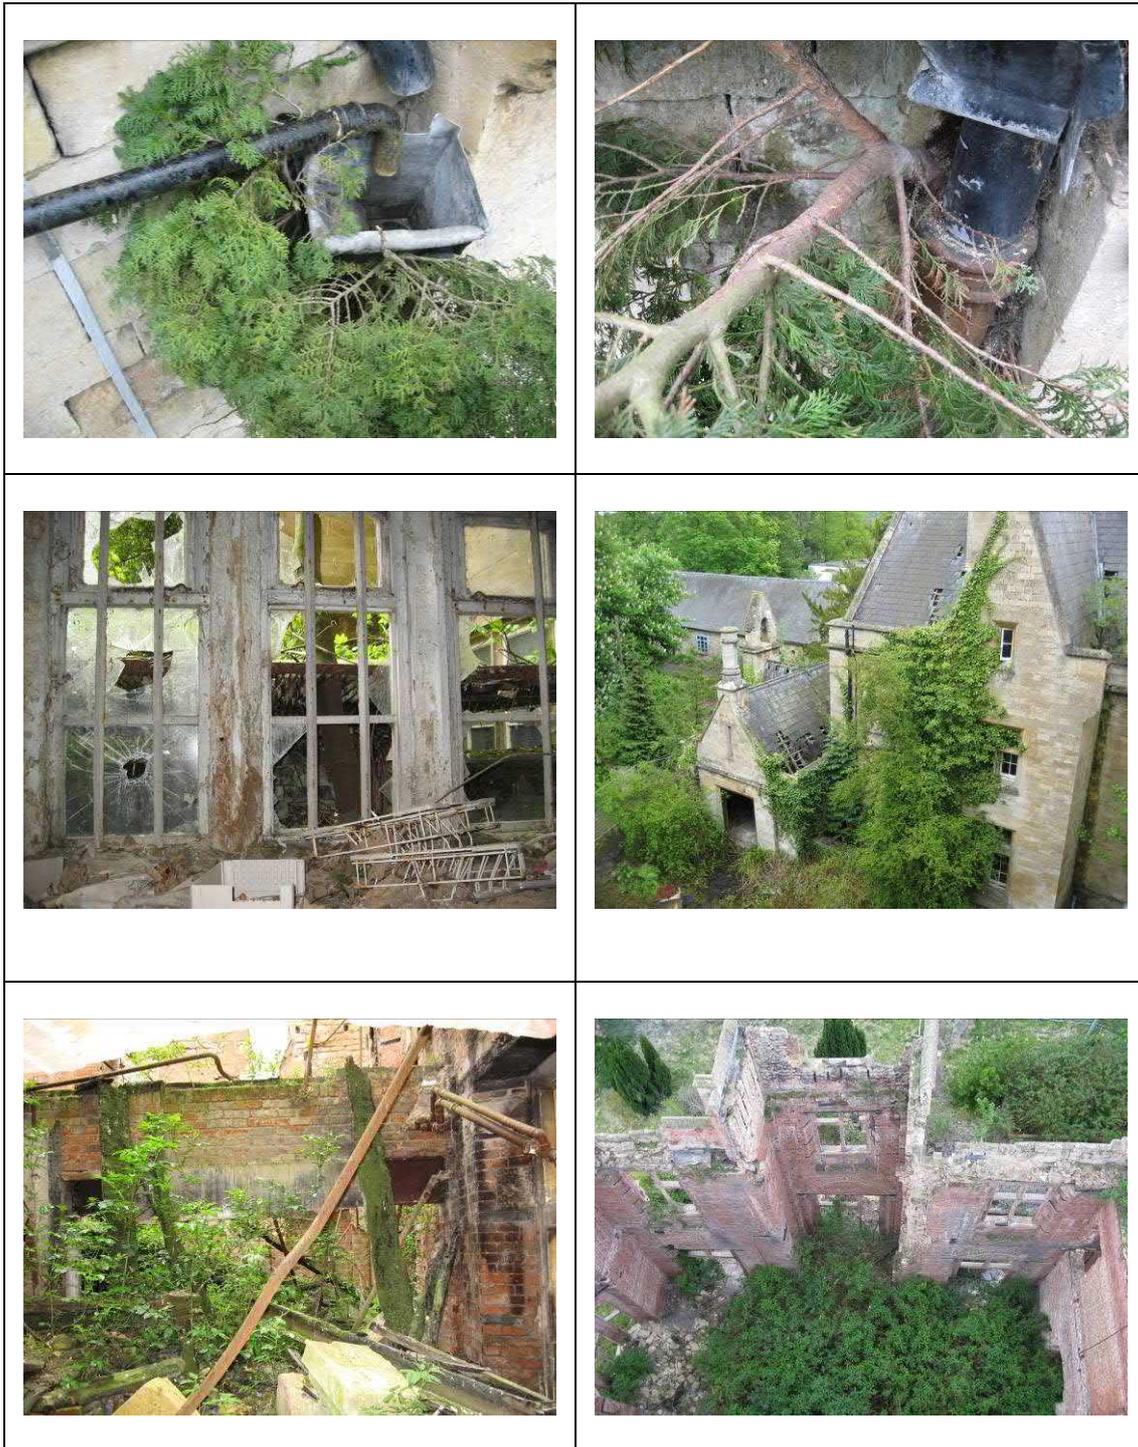
Plate 4:

Top & Centre Row: *External vegetation seriously damaging the historic fabric in 2010.*

Bottom row: *Internal vegetation, if left unchecked has the potential to cause further serious damage to the historic fabric, in 2010.*

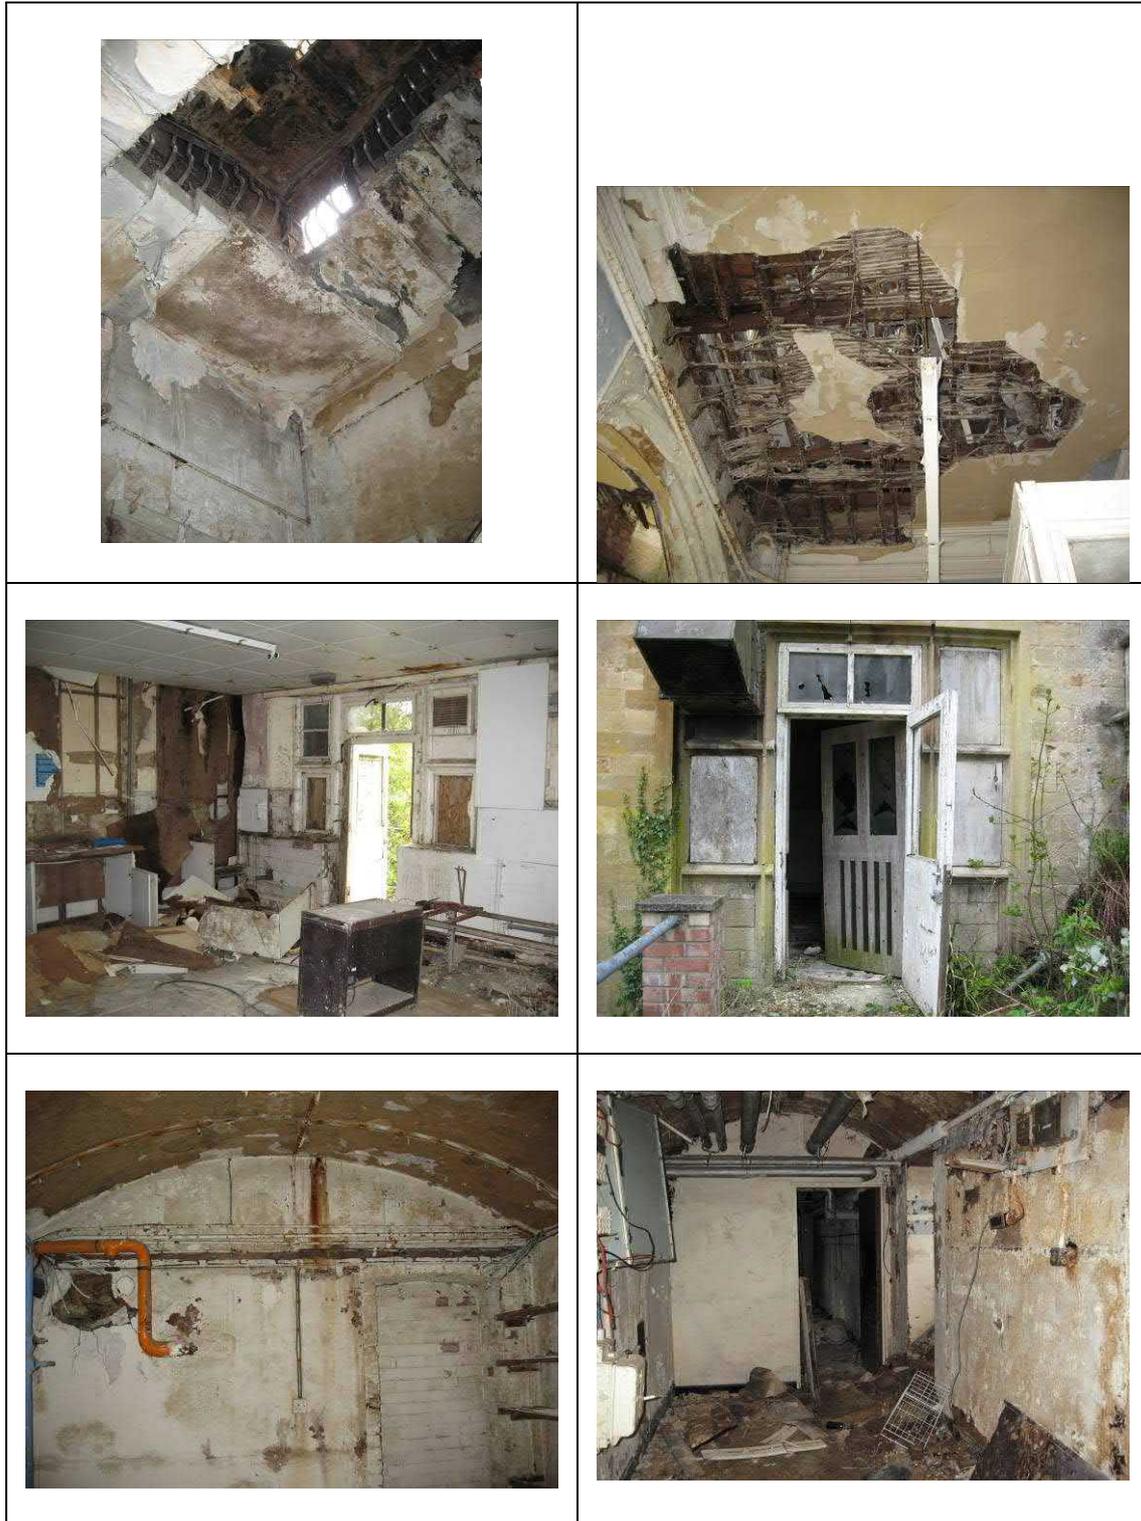
Plate 9:

Top & Centre Rows: *The poor condition of the Service Wing interior.*

Bottom Row: *The poor condition of the Basement.*

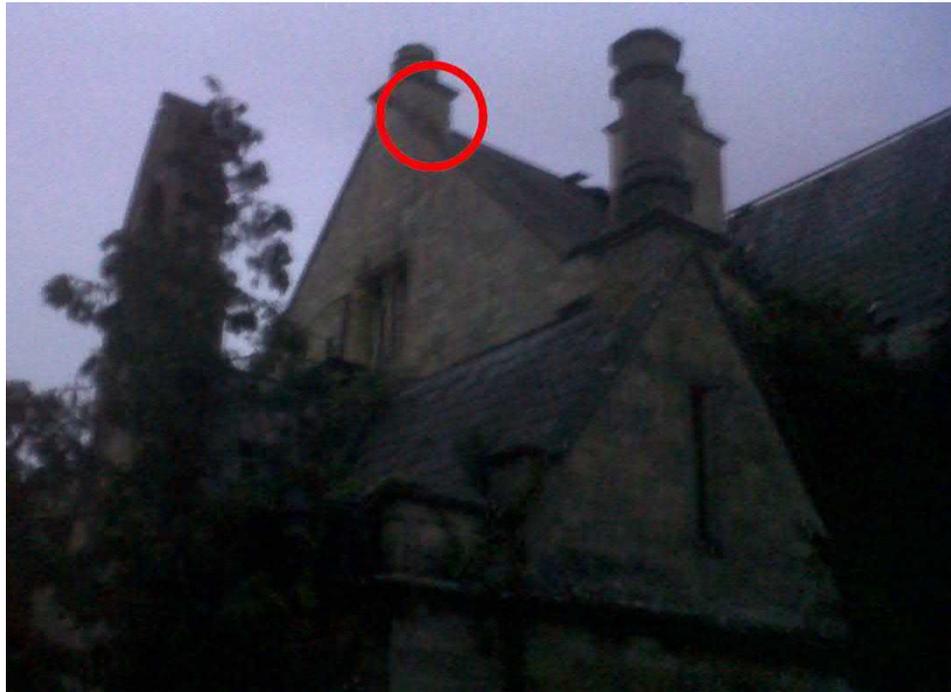
Photograph 5.

Area where brown long-eared bats and common pipistrelle bats emerged – area where the roof covering is still intact

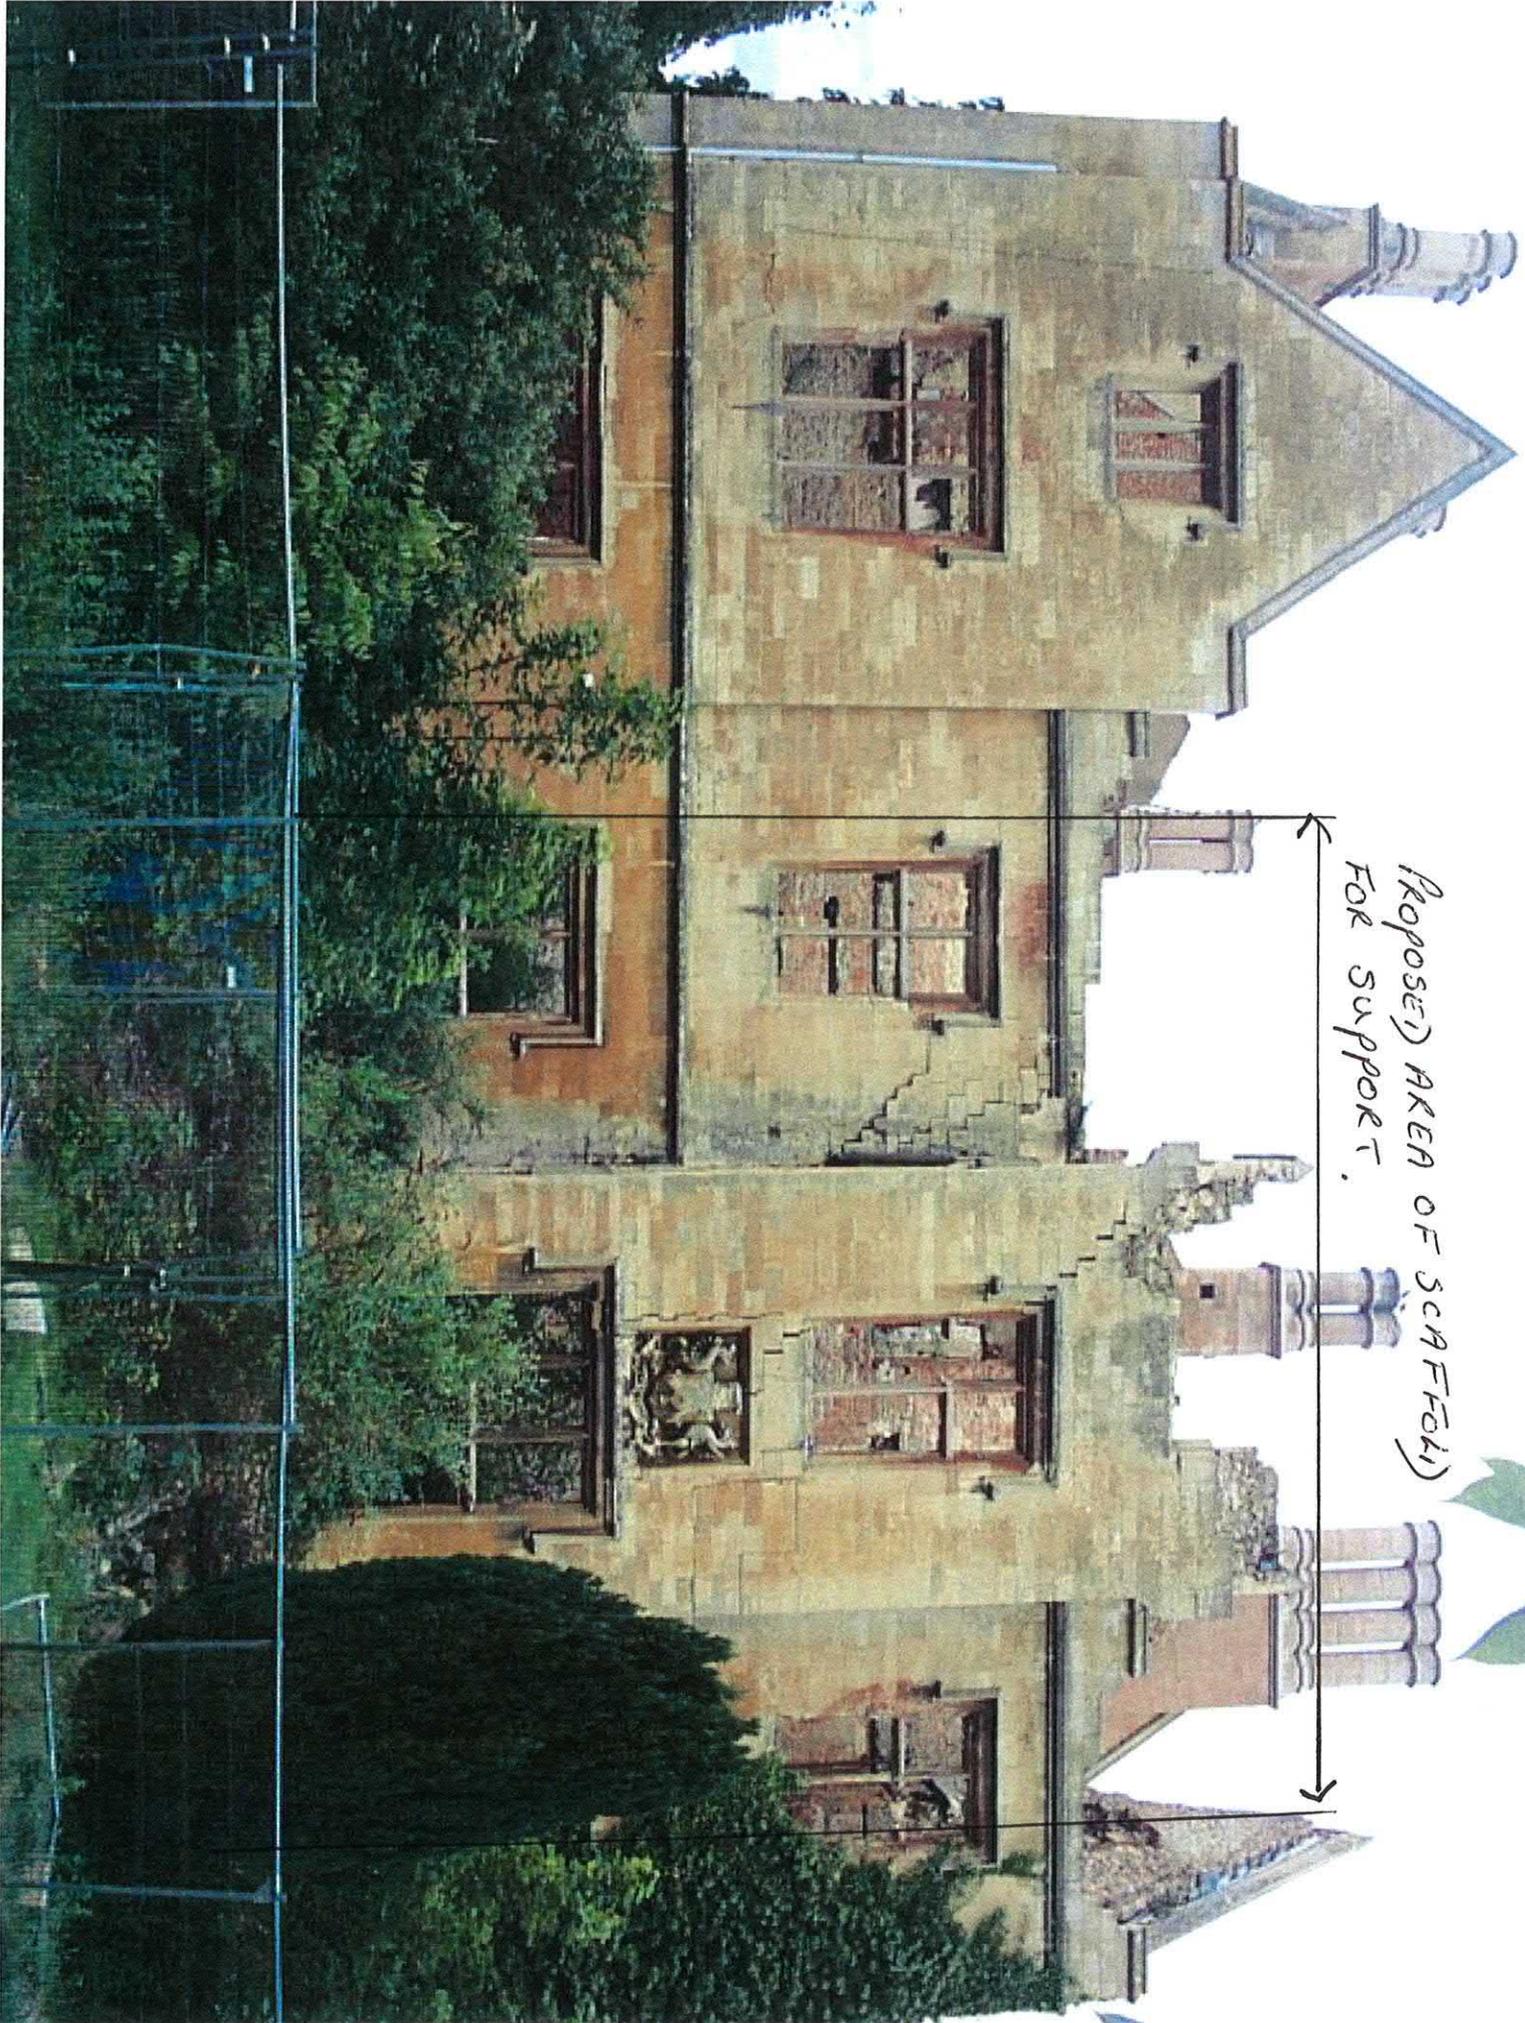
Photo of projecting bay Ref Room A Plan A-164-02.

PROPOSED AREA OF SCAFFOLD FOR SUPPORT.

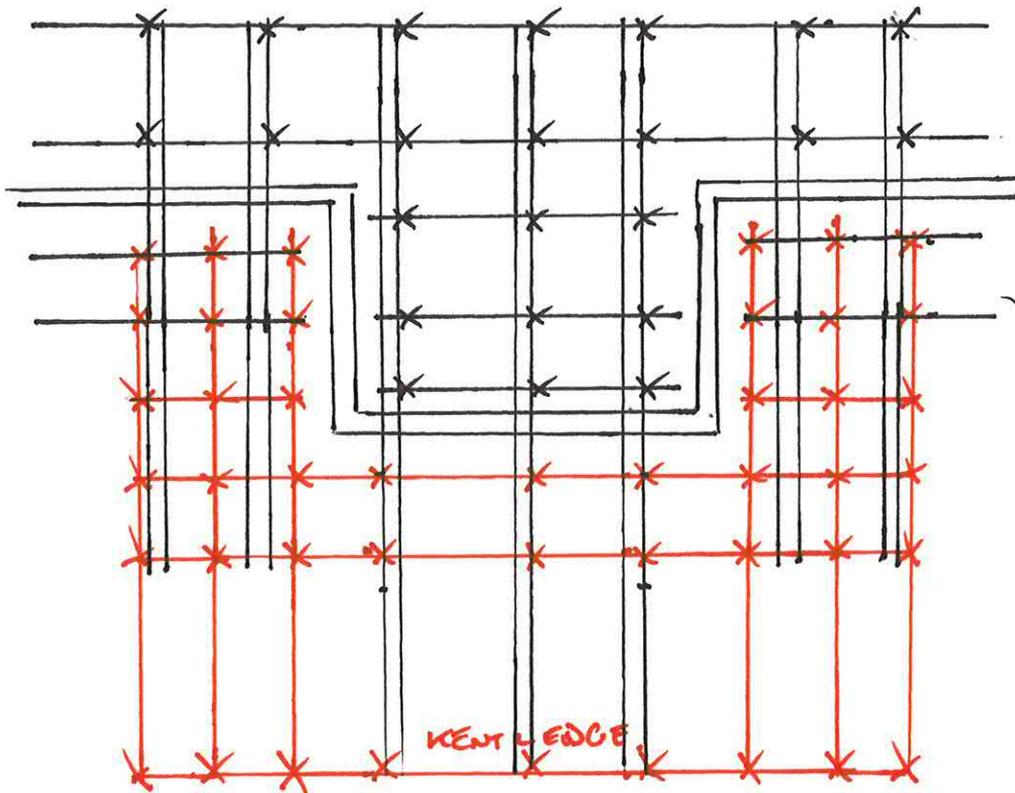
PLAN VIEW OF PROJECTING BAY
 PROPOSED PLAN OF SCAFFOLD TO SUPPORT
 CRACKED CORNER.

BLACK LINES ARE LINES OF UNIT BEAMS.
 RED LINES ARE TRADITIONAL SCAFFOLD
 RED CROSSES STANDARDS TO THE FLOOR
 BLACK CROSSES STANDARDS PUNCHED UP FROM THE BEAMS
 NO STANDARDS DOWN TO THE GROUND INTERNALLY.

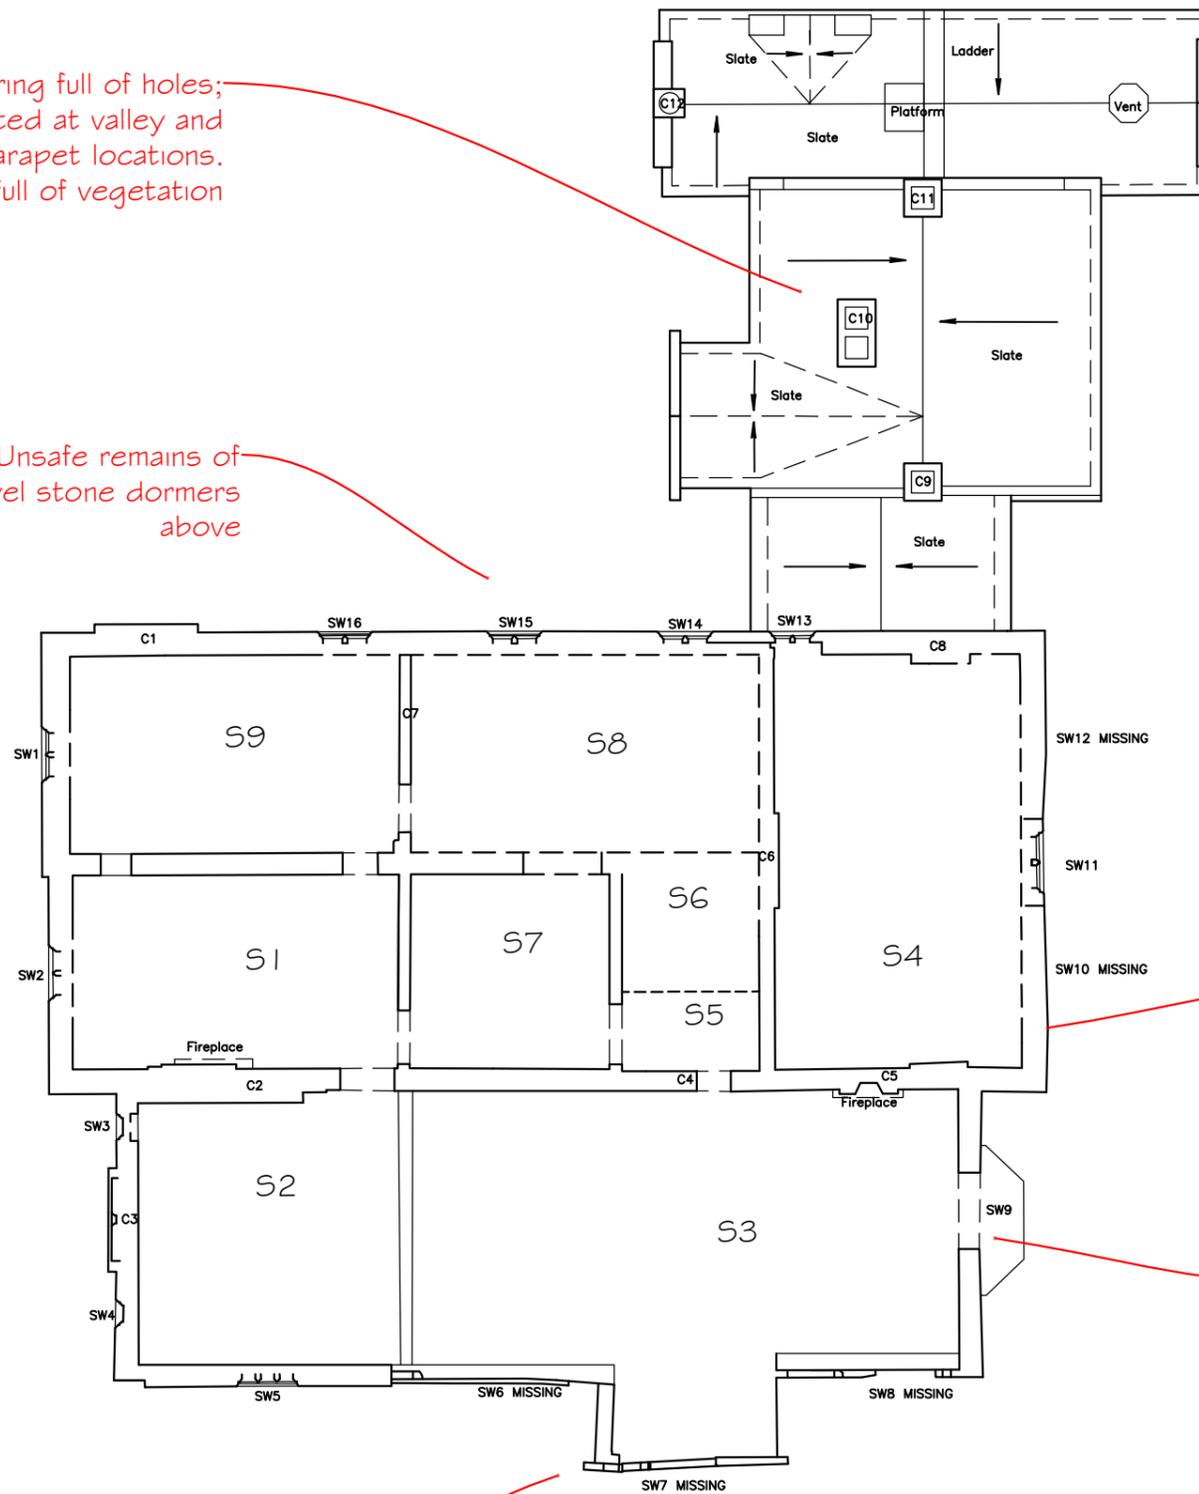
Unsafe remains of attic level stone dormers above

All exposed wall heads covered in loose rubble, slates and pieces of copings

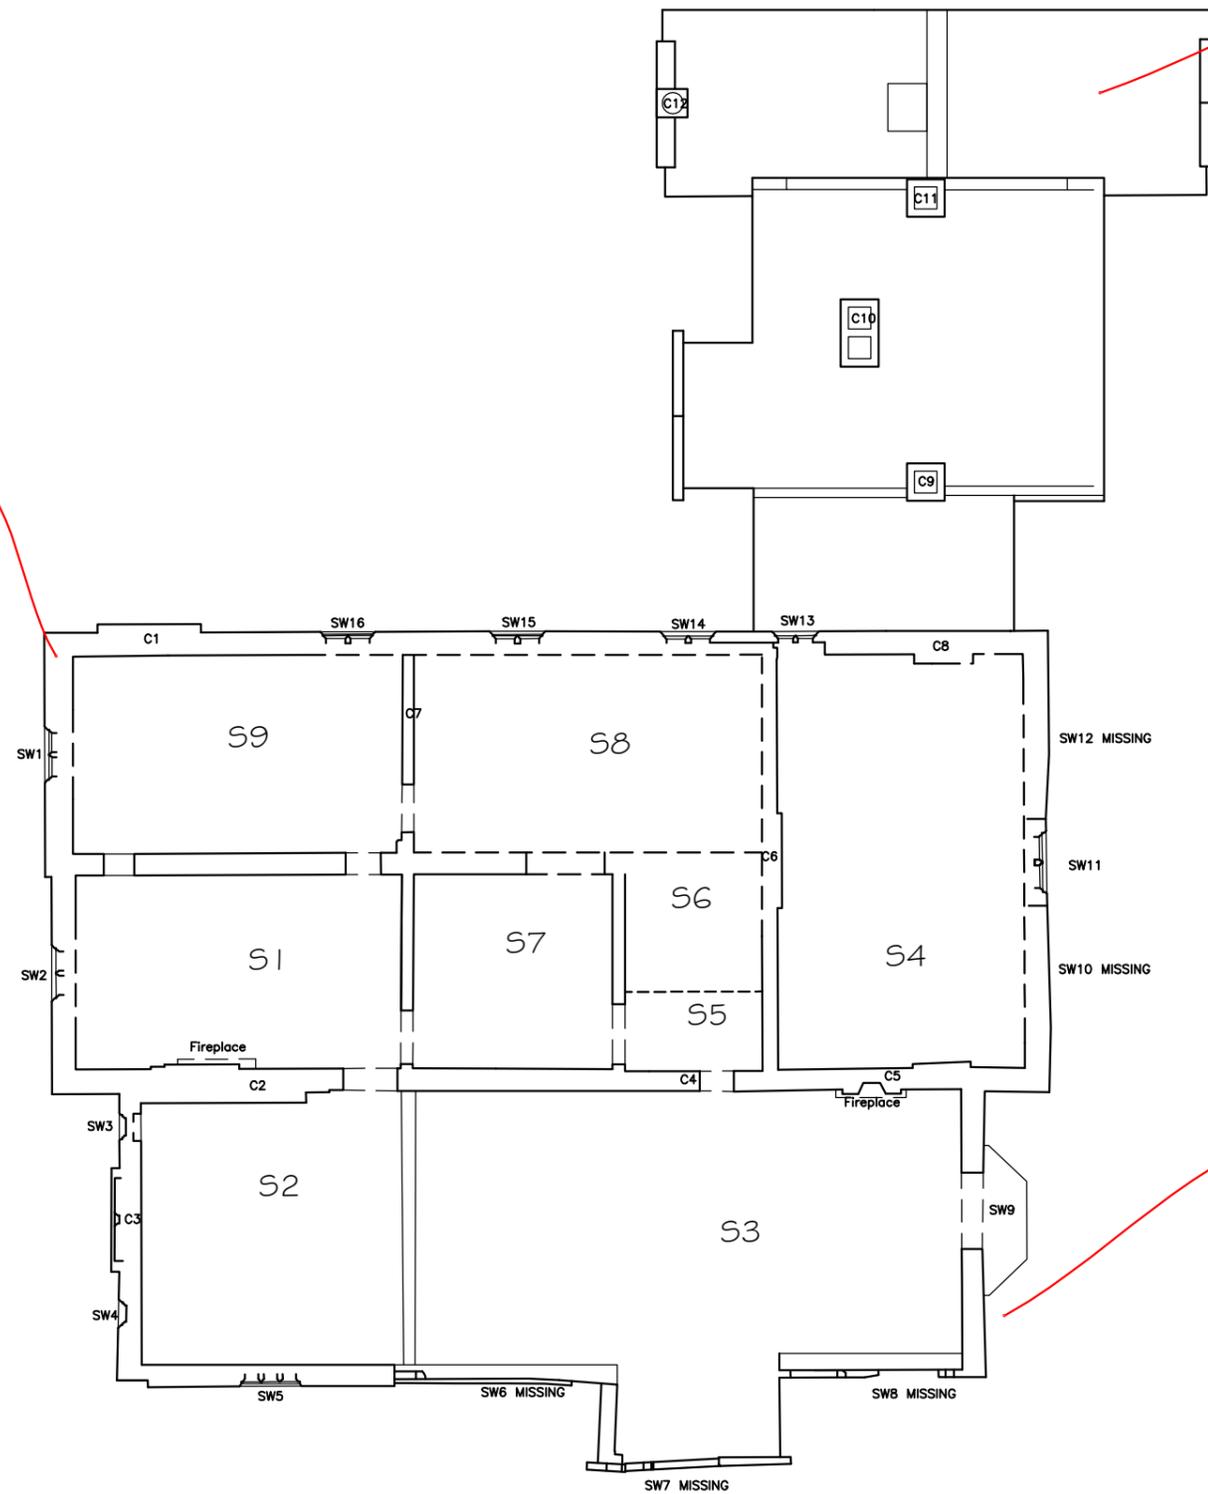
All loose masonry and unstable dormers taken down. Wall head capped with durable copings, following removal of decayed materials and consolidation of wall head.

All free standing gables, and all stacks assessed for structural stability. Additional support given where necessary; Lone stacks generally likely to need removal

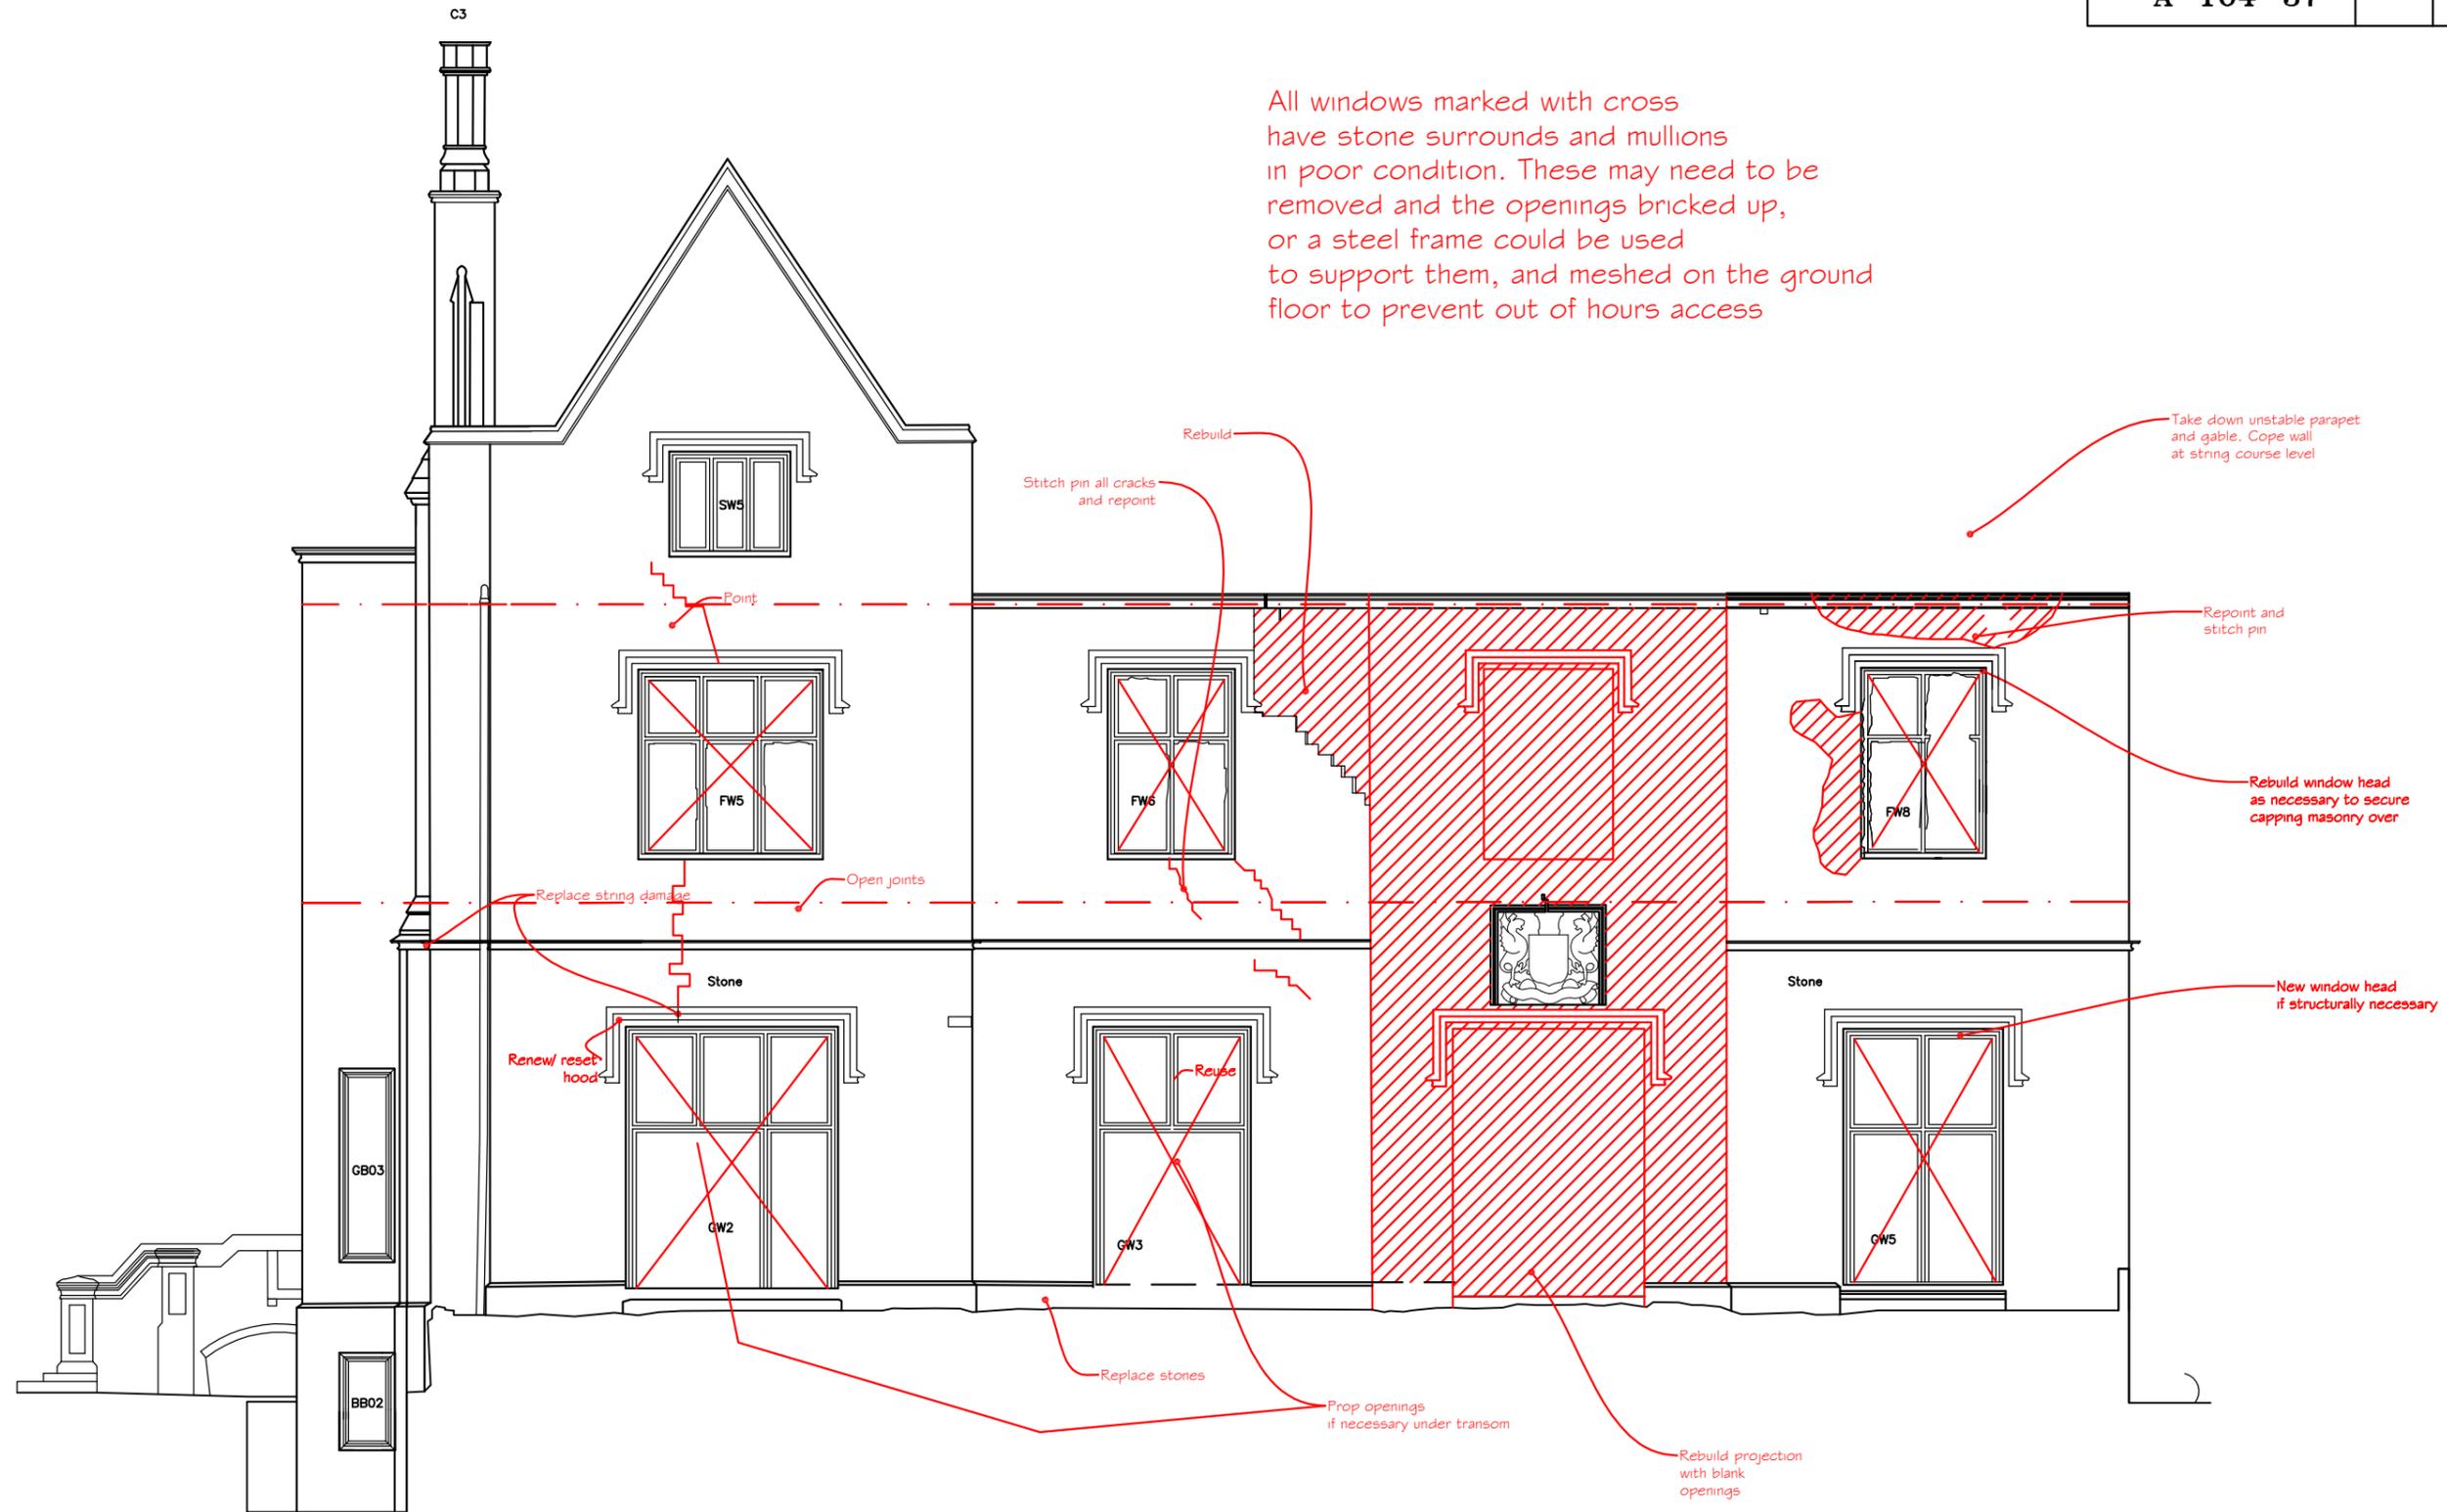
All windows marked with cross have stone surrounds and mullions in poor condition. These may need to be removed and the openings bricked up, or a steel frame could be used to support them, and meshed on the ground floor to prevent out of hours access

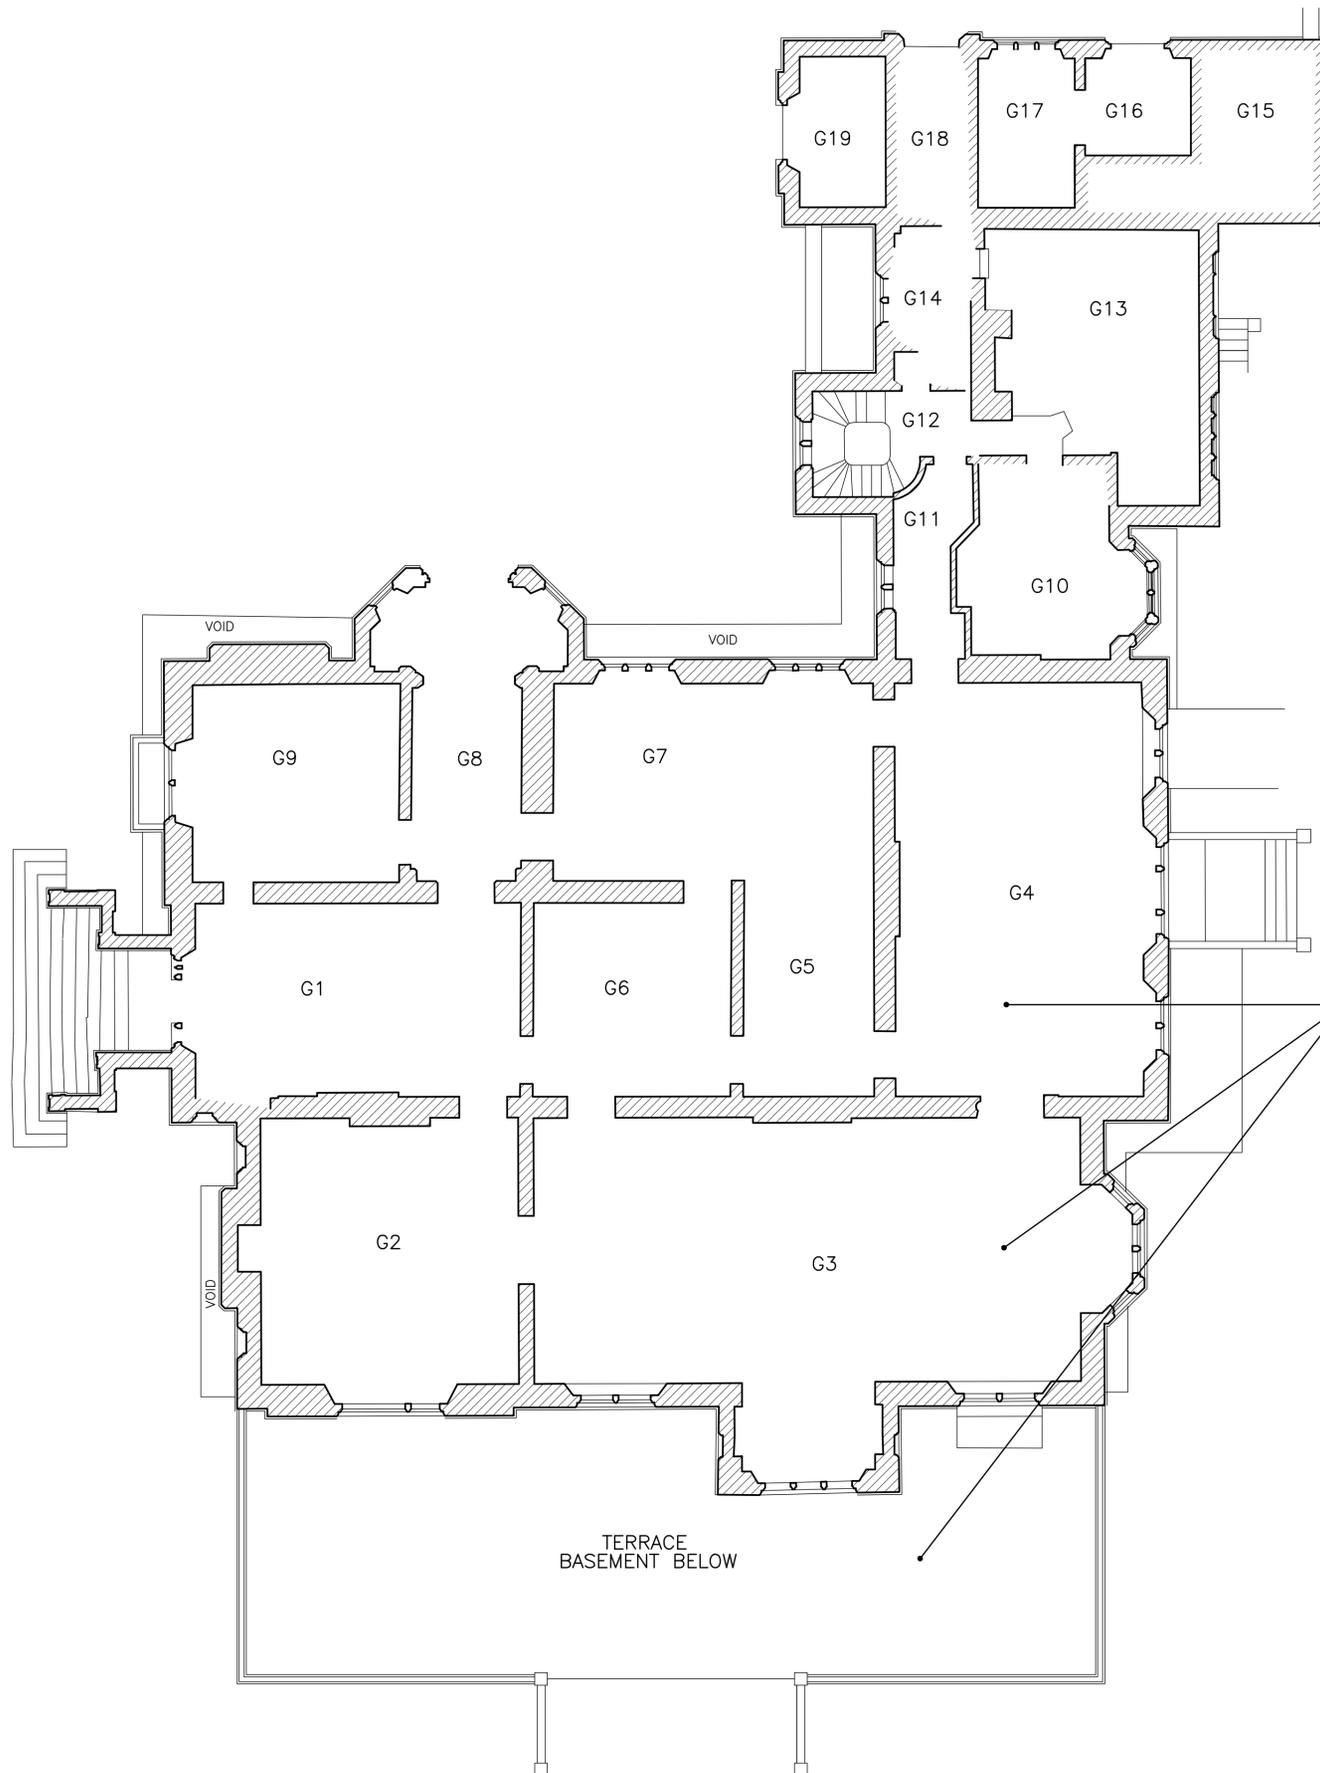
NOTE:
 NEW GROUND FLOOR TO BE SOLID CONCRETE MIN.
 150DP. (GRADE C28/35) SLAB TO BE REINFORCED
 WITH 2 LAYERS A193 MESH 1 TOP & 1 BOTTOM.
 NEW SLAB TO BE CAST ON TOP OF EXISTING VAULTED
 STRUCTURE.
 DETAILS AND LAYOUT OF BASEMENT WALLS UNDER
 NOT SURVEYED.
