Wilsford Conservation Area

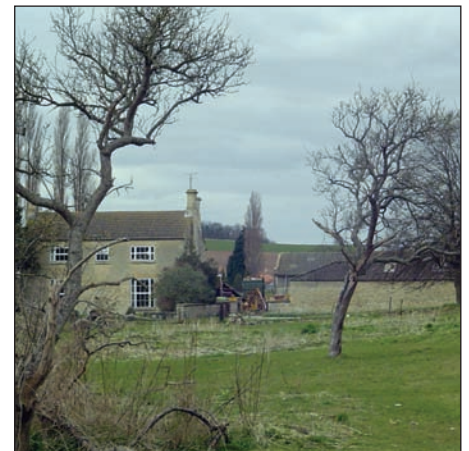
▲ Hanbeck, built in 1847 with its adjacent range of contemporary farm buildings. These are proposed for inclusion within the Conservation Area.

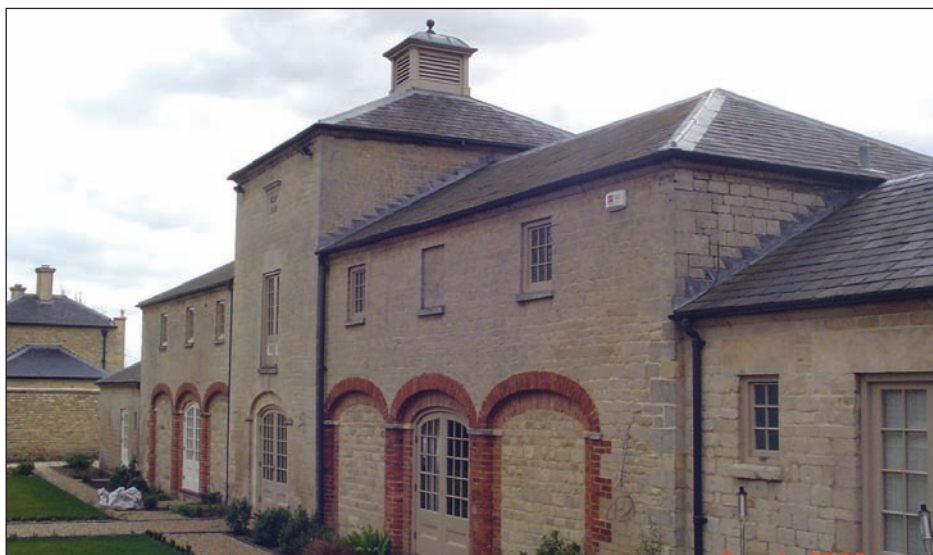
▲ Hall Farm, now converted into a dwelling. This impressive range is a result of it forming part of the setting of the Parish Church and of Wilsford Hall, demolished in 1918.

The centre section of the buildings of Hall Farm. The date stone ► reads CP 1842, the initials of Charles Parkinson who purchased the Estate in 1815.

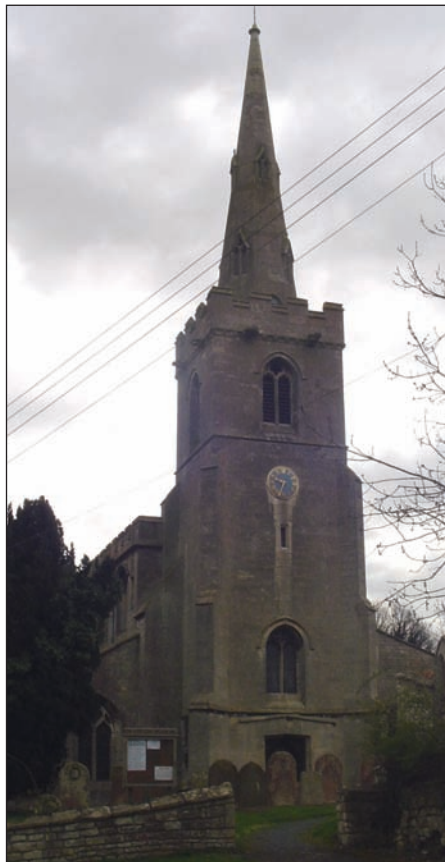
▲ *The Parish Church of St Mary is a Grade I listed building. Buildings with this grade are of national importance.*

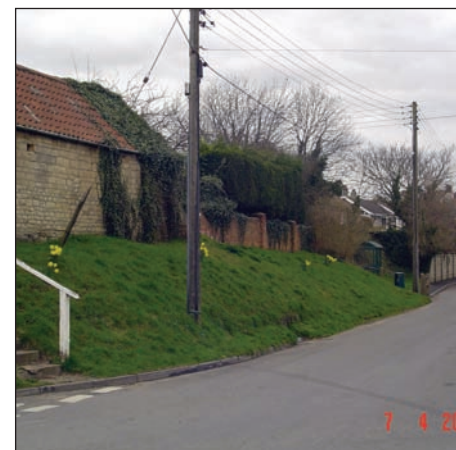
▲ *Where the grass banks survive on the south side of Main Street they form a very distinctive feature of the street scene.*

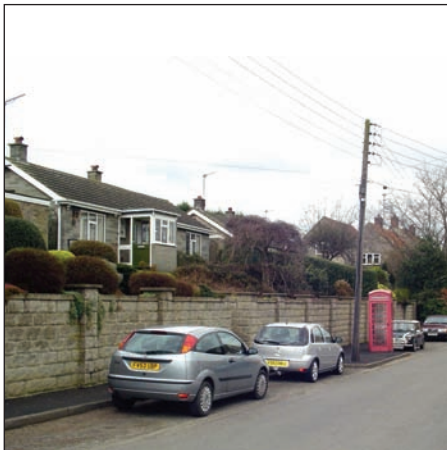
▲ *Main Street was widened when the bungalows on the left were built. Uncharacteristically, the street has been widened to allow for parking bays and the retaining wall has been built of concrete blocks, a contrast to the many stonewalls in the village.*

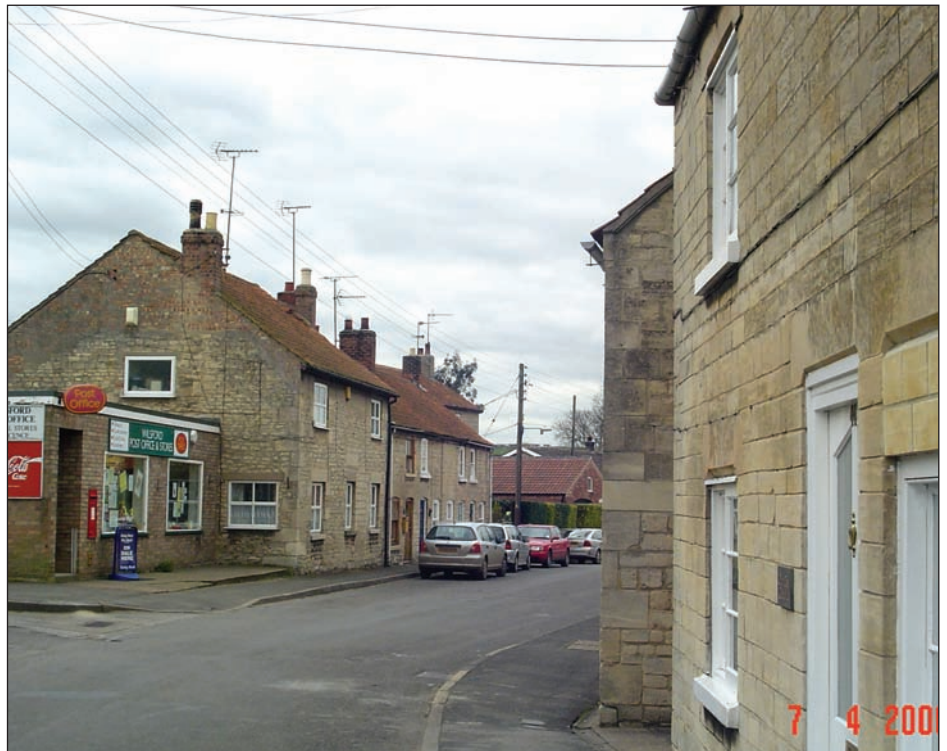
▼ *The pinch point on Main Street where buildings on both sides are against the road. The Post Office, with its flat roof, signage and white painted fascia boarding contrasts with the form and detailing of the traditional buildings.*

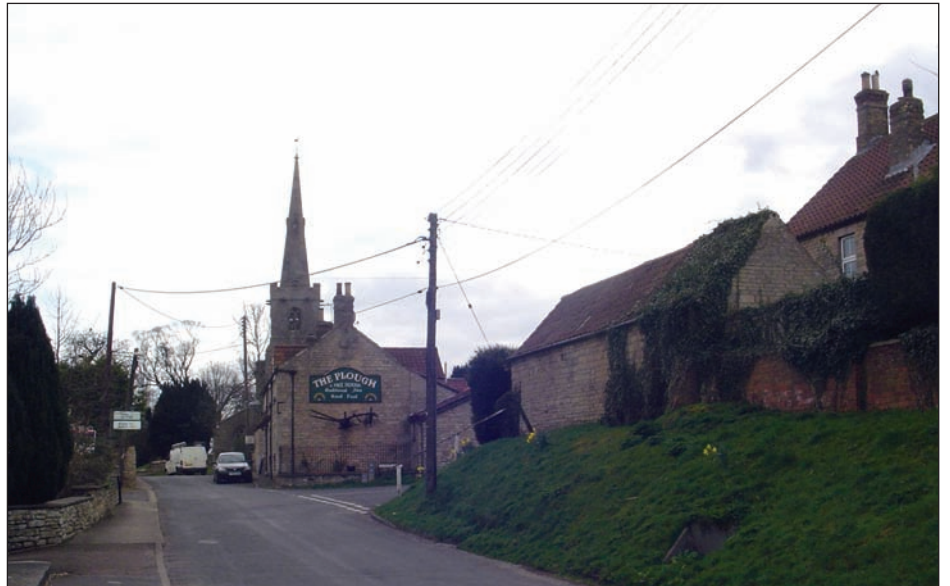
▼ *The Plough and the Parish Church at the east end of Main Street.*

▲ *The view east along Main Street is closed by the Plough and the Parish Church. By contrast, the overhead wires do intrude.*

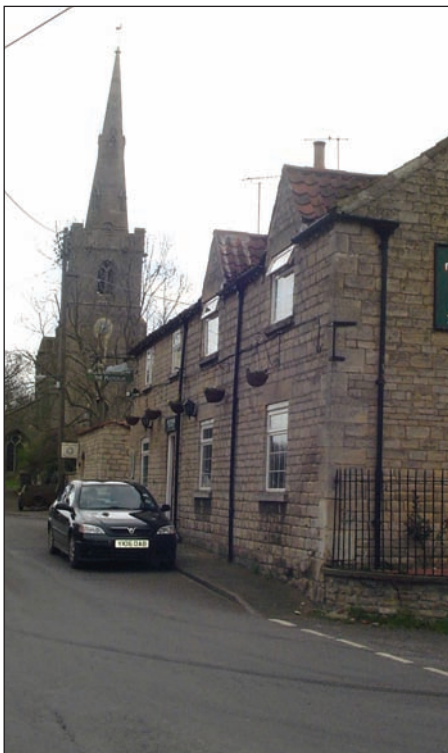
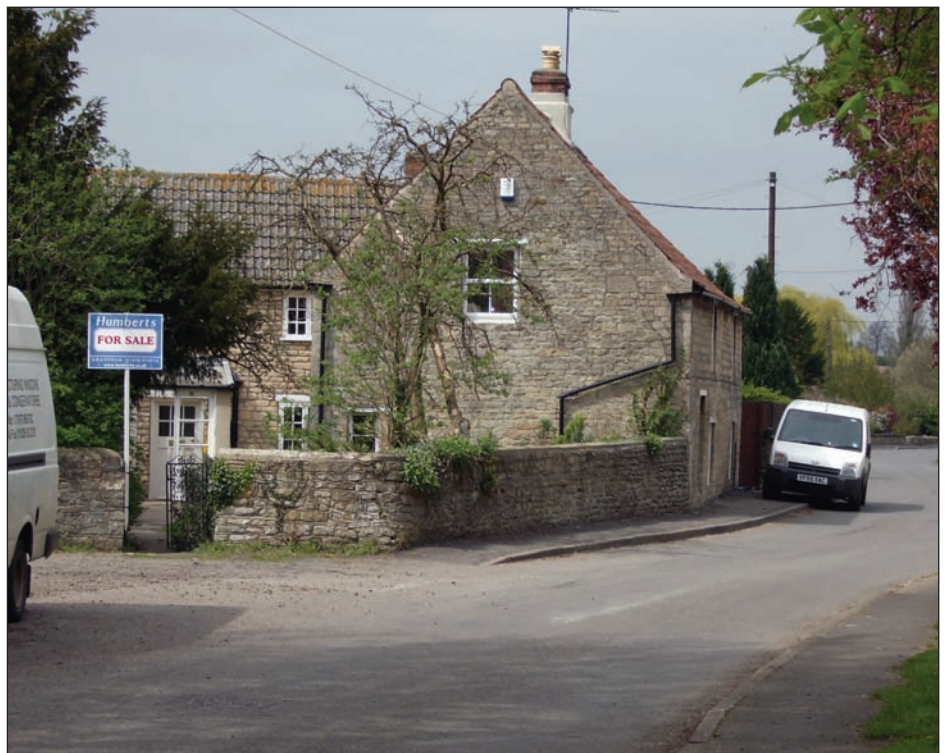
▼ *57 and 59 Main Street close the view along Main Street at the western end of the Conservation Area.*

Individual buildings become important when they close views along the street. At the east end it is the Parish Church tower and The Plough that close the view. To the west Home Farm first encloses the evolving views with buildings again tight to the north side of the road, and then 57 and 59 Main Street. Beyond this point the character changes, the enclosure of the view is lost with bungalows set back within long front gardens to the south and views of open countryside to the north west. In the reverse direction the front elevation of 39/41 Main Street is prominent.

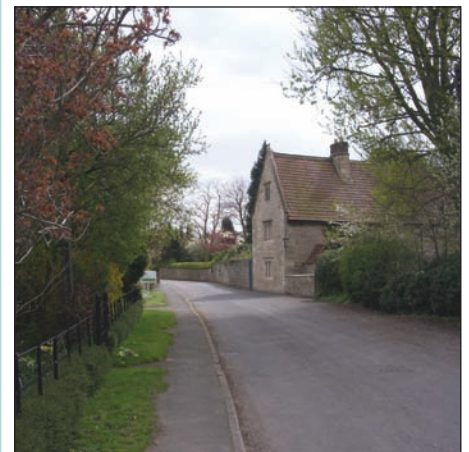
▲ Home Farm is prominent in the street scene at the western end of the Conservation Area. A Grade II listed building, it dates from the early C17 with C19 and C20 alterations.

Home Farm is a farmhouse dating from the C17. Listed Grade II it is of local importance. The former farmbuildings are also considered to be listed by virtue of having been within the curtilage of Home Farm at the time the latter was listed.

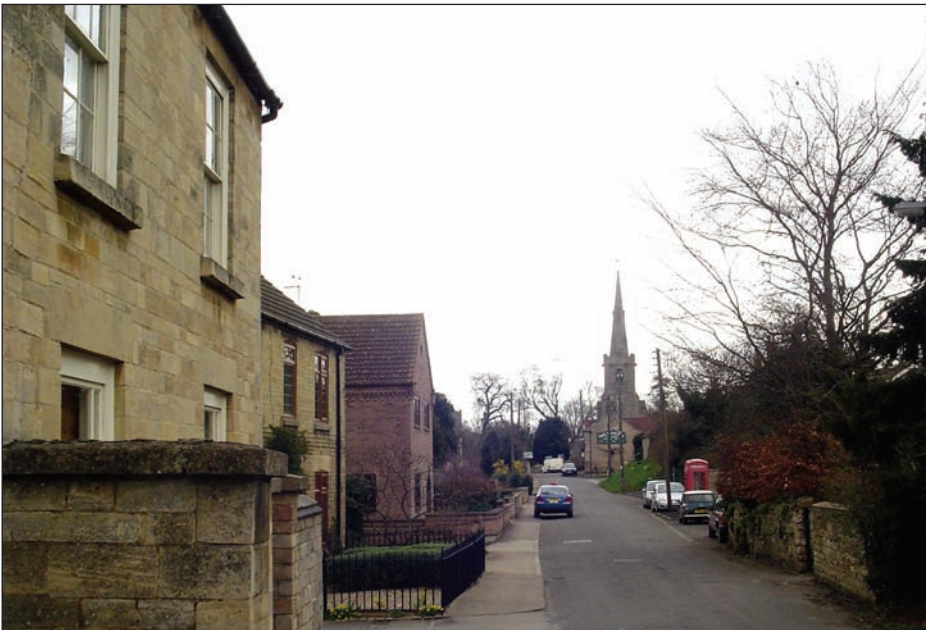
▼ *A view east along the street shows the contrast between the north side of the road, closely built up to the footpath, with trees and green spaces to the south. The spire of the Parish Church gives a strong sense of place.*

The Parish Church is prominent within the views from the west along Main Street and at the south end of School Lane. The spire, in particular, is seen in longer and wider views and provides a punctuation point to identify Wilsford in the approaches from the east, west and south. Home Farm is less prominent in the wider views but does close the view to the west along the west end of Main Street.

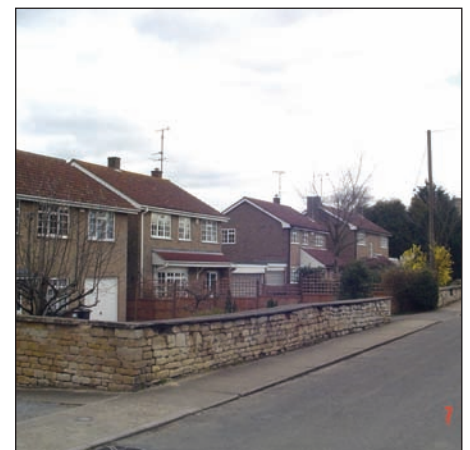
▲ 14 to 20 Main Street were built back from the road edge and the tight enclosure to the street here has been lost. Stone walls, so typical of the street, line the back edge of the footpath.

Another important feature are the number of, predominantly, stone walls to Main Street. They are capped with a mix of concrete, stone, pantile and brick copings. Stone and pantile are the traditional forms of coping for stone walls. These walls serve as boundary garden walls to buildings on the north side of the street and retaining walls to those on the south. As a rule of thumb the walls are constructed of the same material as the buildings with which they are associated. Where stone walls remain, however, efforts should be made to retain and maintain them. Copings are a mix of concrete, stone and pantiles.

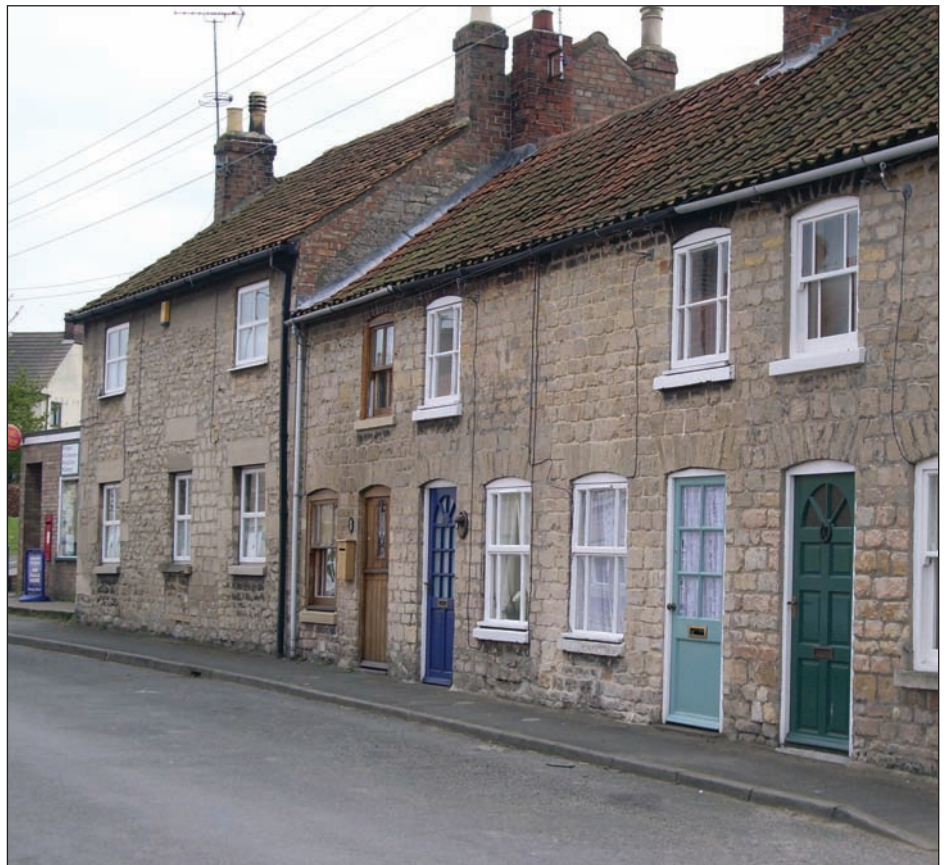
▼ *Mellow limestone walls and clay pantiled roofs are typical of the Conservation Area. The terrace on the right, 33 to 37 Main Street, has margin light windows. The surviving traditional sliding sash windows at either end have a step where the upper and lower sashes meet. This brings relief and interest to the façade of the building, a feature missing from the flush faces of the windows in the centre.*

Windows are generally of timber and are taller than they are wide. Sash windows, sliding vertically, are common, and on smaller cottages the Yorkshire Sash, sliding horizontally, can still be found. This, especially in its three section form, is wider than it is deep. Windows are set back slightly from the face of the wall and this, together with the step in the traditional sash window forms brings relief to the facades of buildings.

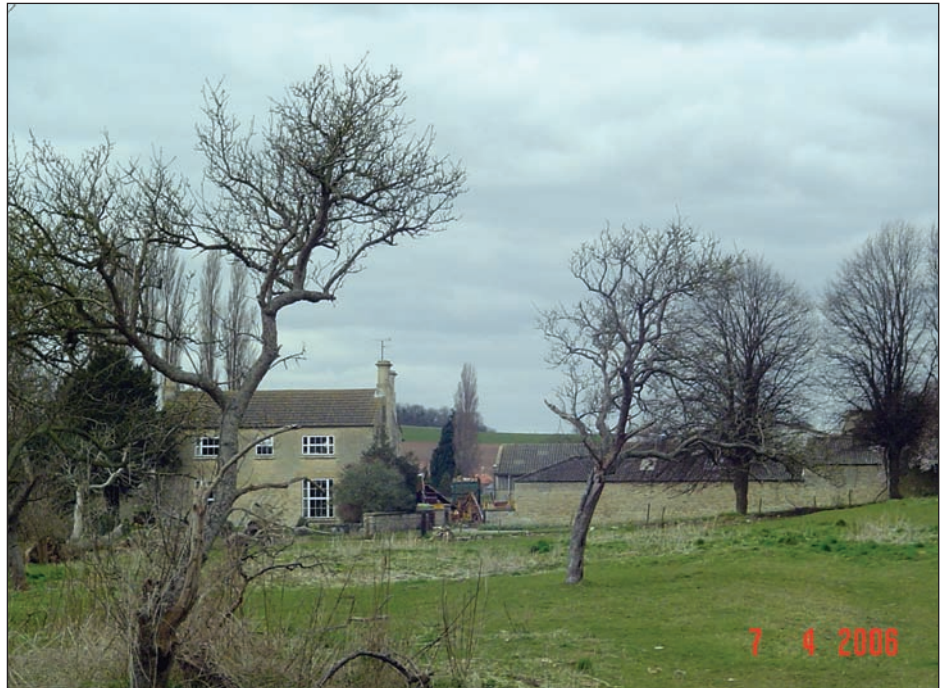
▲ Hanbeck, built in 1847 with its adjacent range of contemporary farm buildings. These are proposed for inclusion within the Conservation Area.

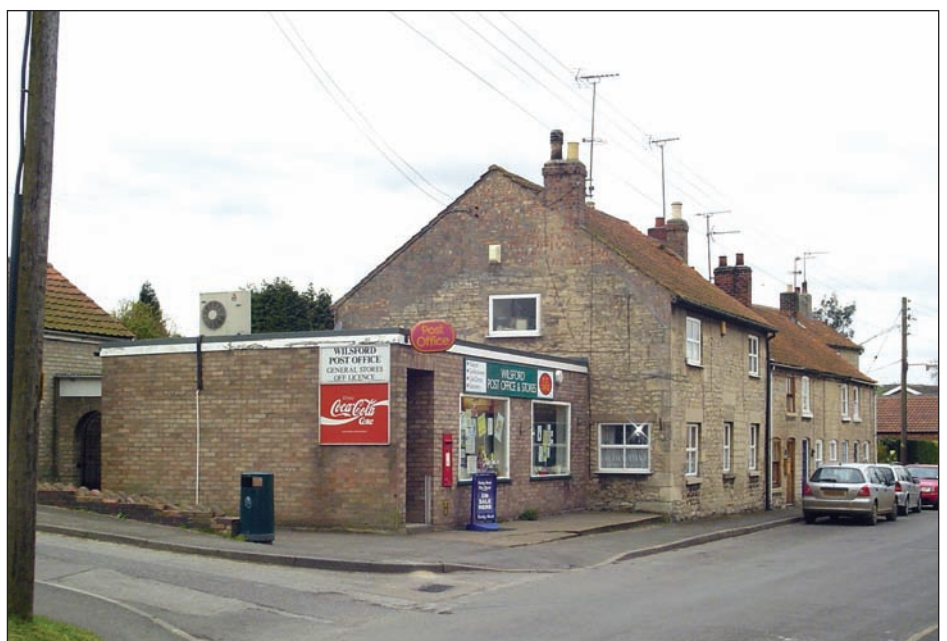
▼ The Post Office, with its flat roof, signage, white painted fascia boarding and air conditioning unit contrasts strongly with the more traditional buildings of the area.

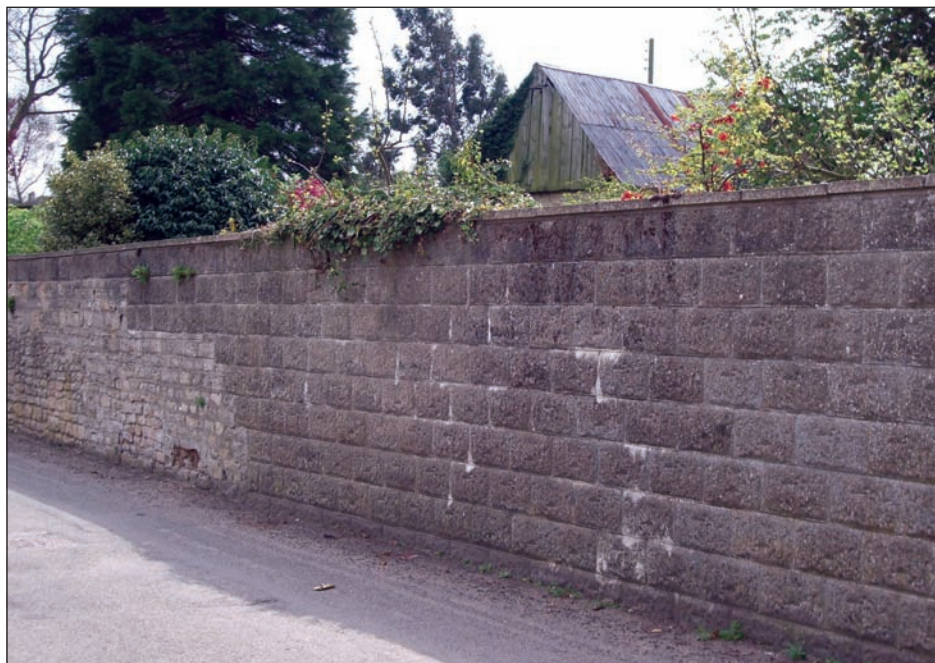
▼ *The garden to Home Farm has an impressive boundary wall. A large section of it has been rebuilt in concrete blocks. The rebuilding in coursed limestone rubble would be a marked enhancement to this part of the Conservation Area.*

There may be opportunities in future to resolve at least some of these conflicts and they are the issues referred to in paragraph 2.3 above. Walls can be rebuilt or refaced; overhead wires replaced with an underground service; white boarding can be painted a colour to match brickwork; and hedges cut back. The effect of the houses set back from the street could be reduced if any future extension could be to their front rather than the back.
