VERIFICATION REQUIREMENTS FOR COVER SYSTEMS

Technical Guidance for
Developers,
Landowners and
Consultants

Yorkshire and Humberside
Pollution Advisory Council

Version 3.2 – October 2014

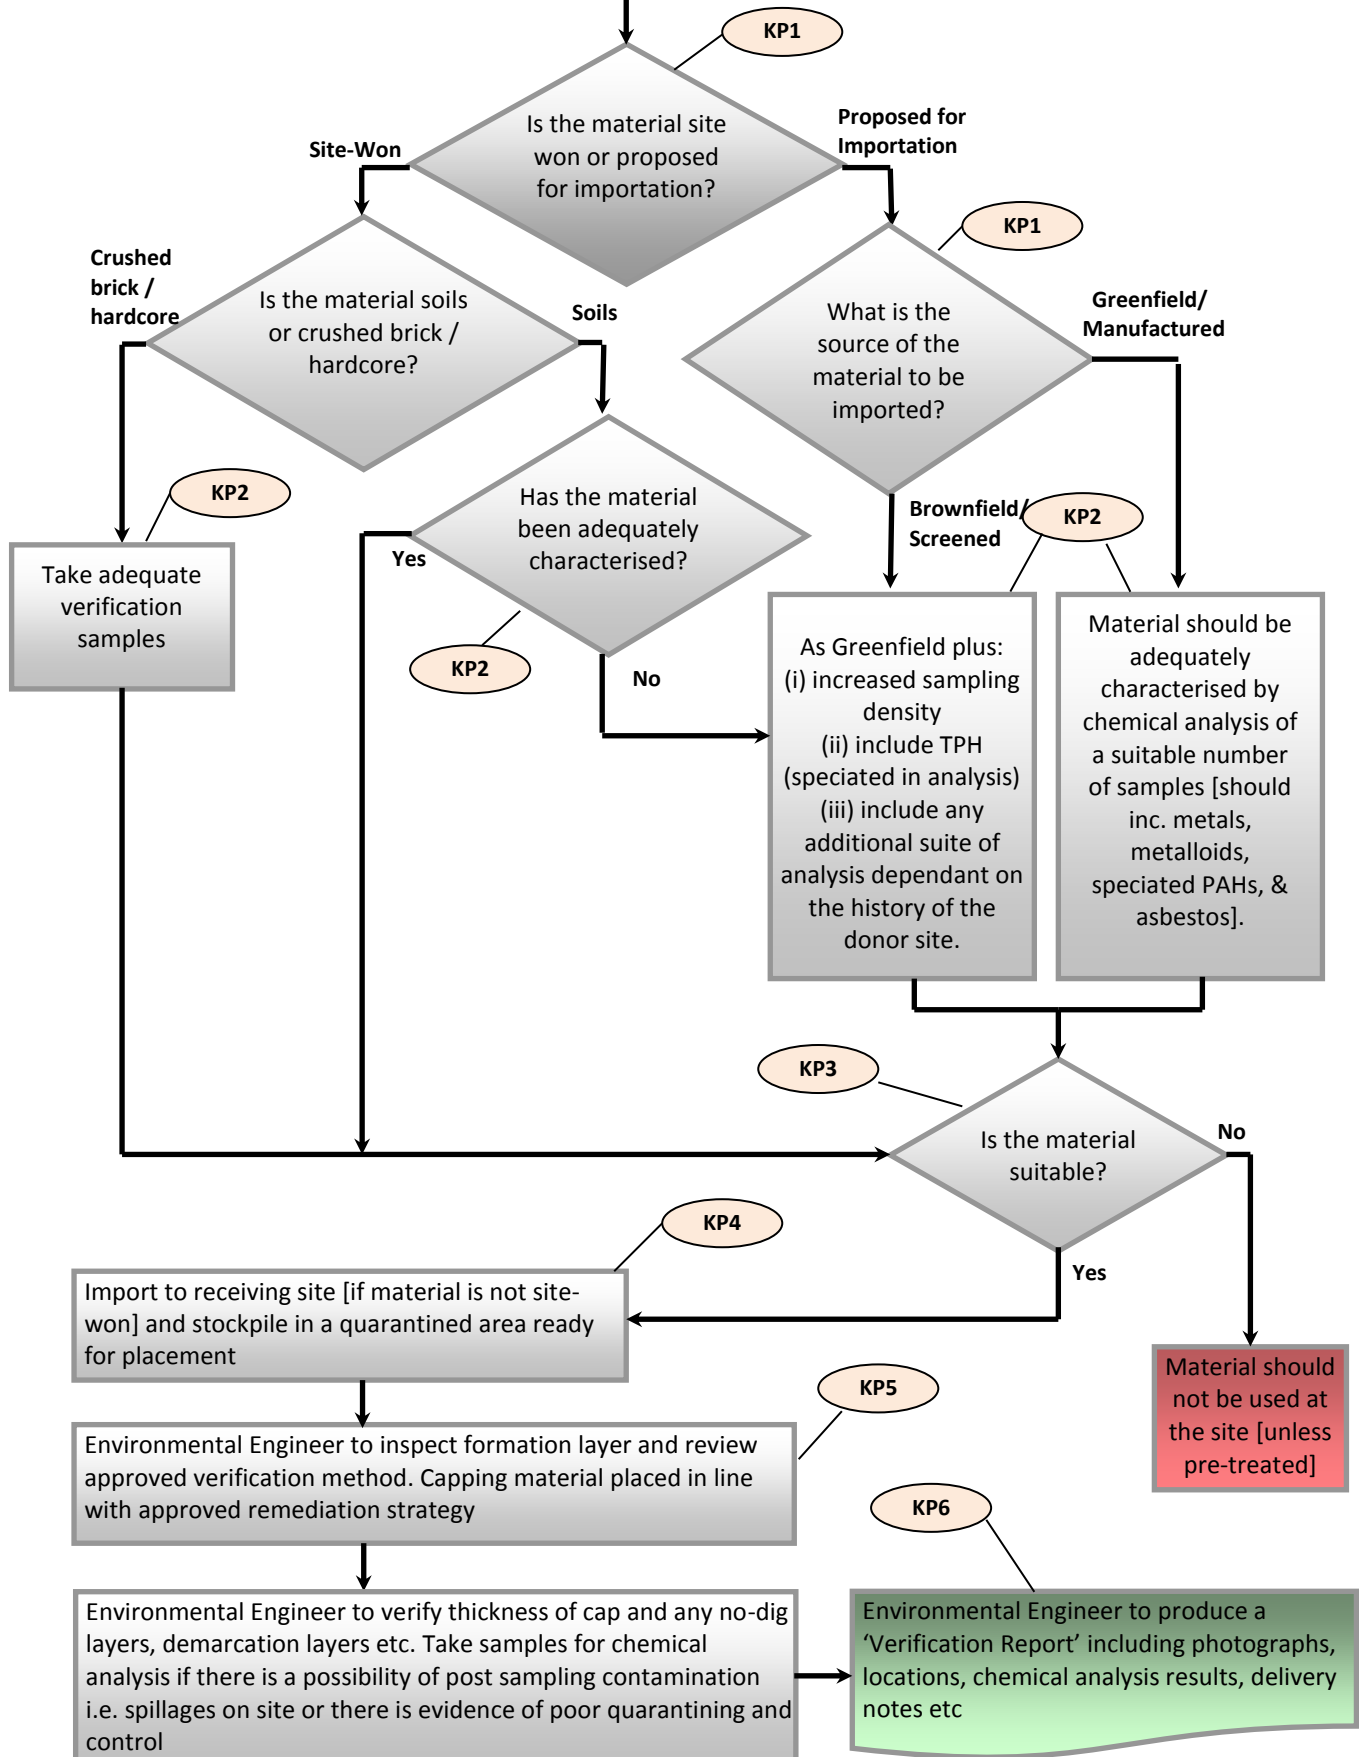
Overview Flowchart

Agree 'Remediation Strategy' with regulator. Decision on the required depth of cover and any need for:
 (i) Physical no-dig layer (ii) Capillary break layer (iii) Demarcation Layer

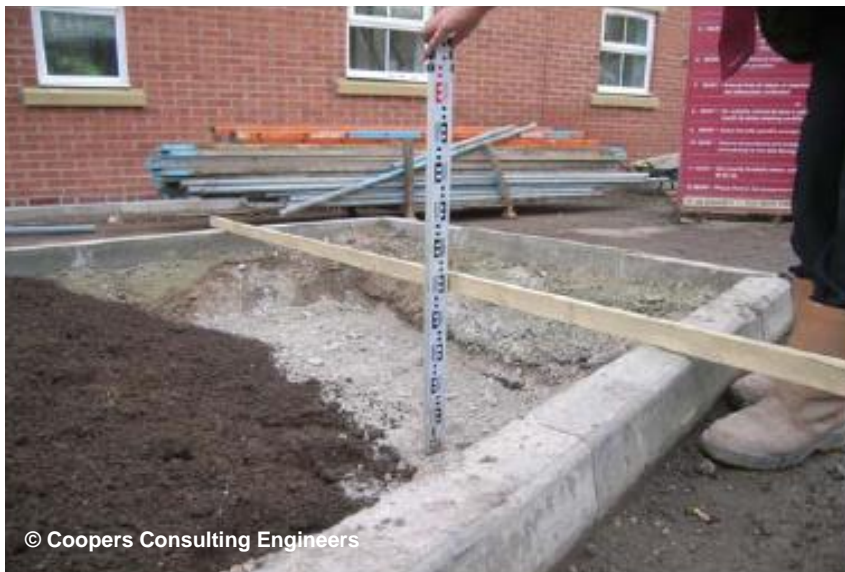
Photograph 1: Depth check of inert cover within area of public open space. Physical break layer and topsoil visible.

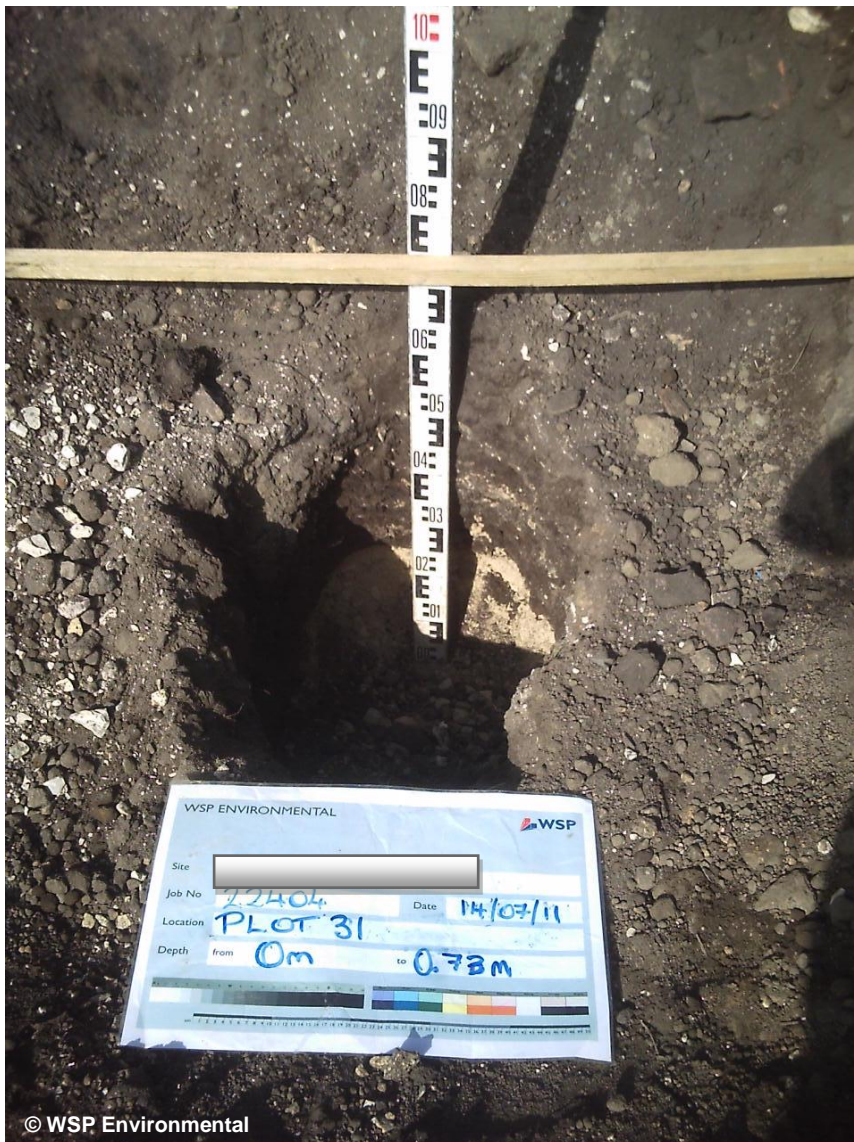
Photograph 2: Depth check of inert cover with Site & Location Information Board.
