Urban Opportunities Study

Sleaford,
Lincolnshire

Lincolnshire Rivers Trust

Report Reference:
CLE20157/005/01

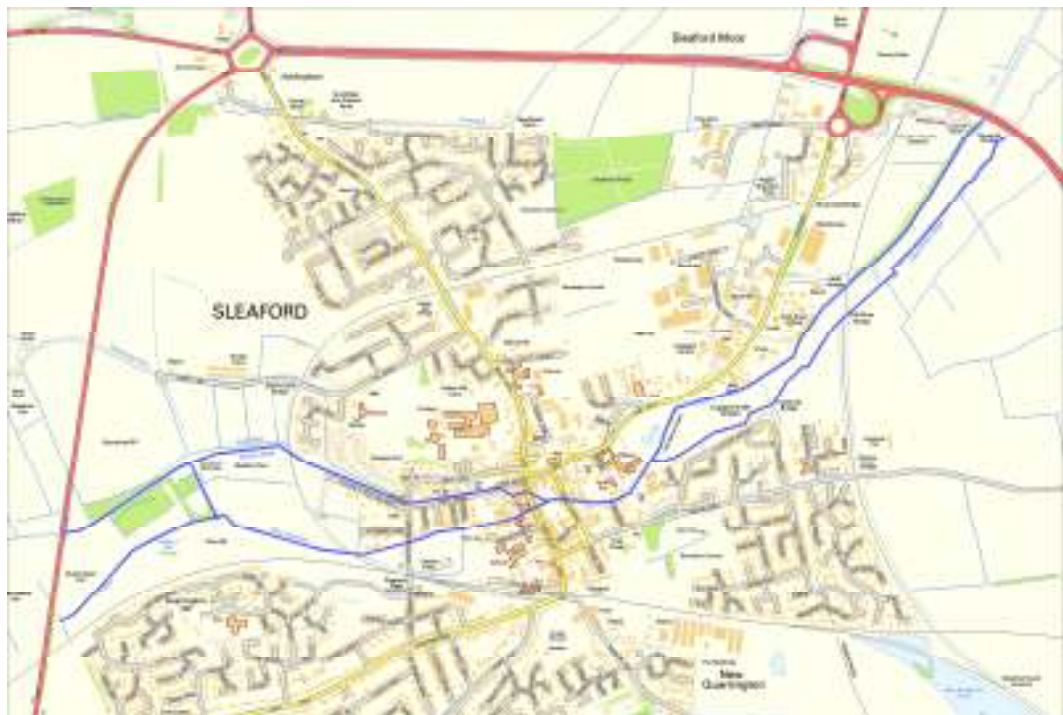
Figure 1: Site location plan (blue line denotes waterbodies under consideration)

The site comprises an approximately 4.1km stretch of the River Slea and surrounding waterbodies and tributaries, grid references TF 05117 45631 - TF 08425 47115. The Slea enters Sleaford via two watercourses, the River Slea and the Nine Foot River, which are additionally fed by springs. It passes through farmland before entering the centre of the town. To the east of Sleaford the river passes alongside an industrial estate before entering predominantly arable countryside. The location in a local context is illustrated on Figures 1 and 2:

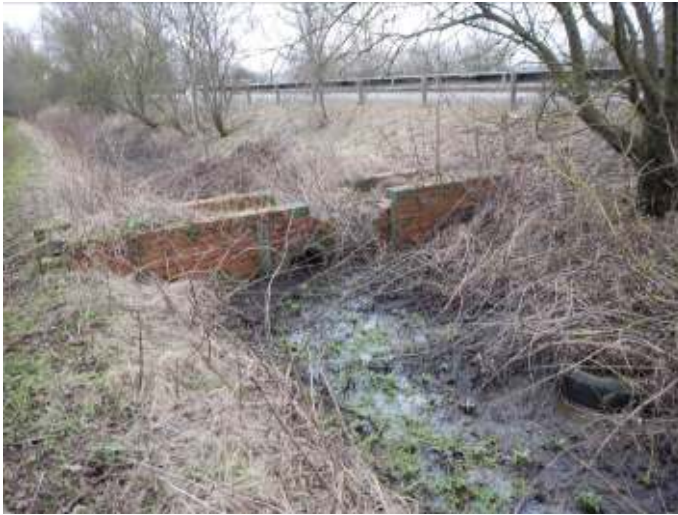
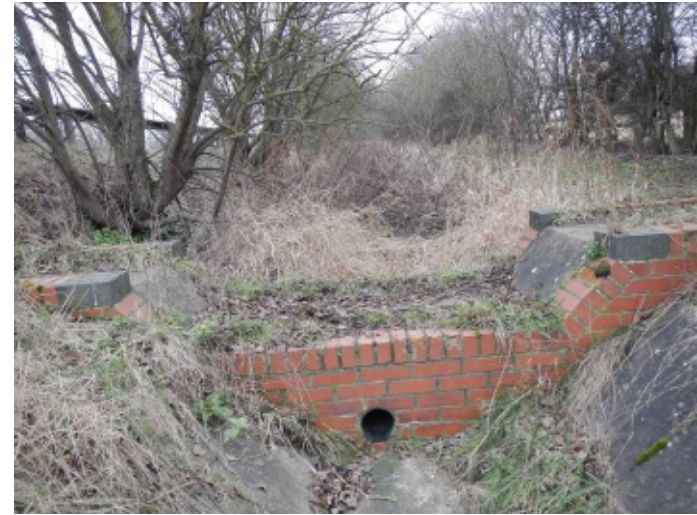
Identified opportunity	Grid ref	Scope	Constraints	Primary themes	WFD MM ⁶	BOMS ⁷	Figure no. in App. E
1	Upstream farmland management	TF 05063 45619	A large amount of aquatic vegetation is present in the River Slea upstream of the A15 indicating potential high nutrient input from surrounding farmland. A scheme is required to reduce nutrient runoff: better education and land management e.g. increased buffer strips. Investigate Countryside Stewardship.	Land owner incentives	Water quality, Riparian habitat improvement		✓	4
2	Reed bed filtration of road side ditch	TF 05110 45647	A roadside ditch is present along the A15, during the survey it was damp (no standing water), evidence of road run-off (petrol / oil sheen / rubbish). An overflow pipe led directly into the River Slea. To prevent potential pollution issues, the ditch should be dredged and a reed bed installed to filter the water before it enters the Slea.	Dredged material may be contaminated waste	Water quality, riparian habitat improvement	✓		5, 6

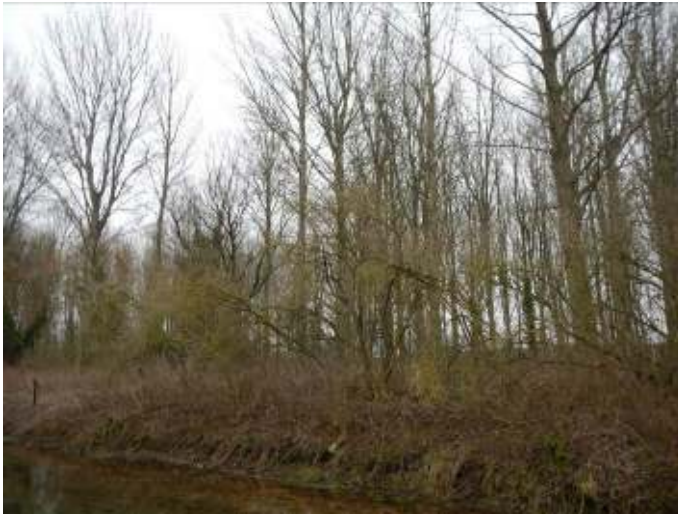
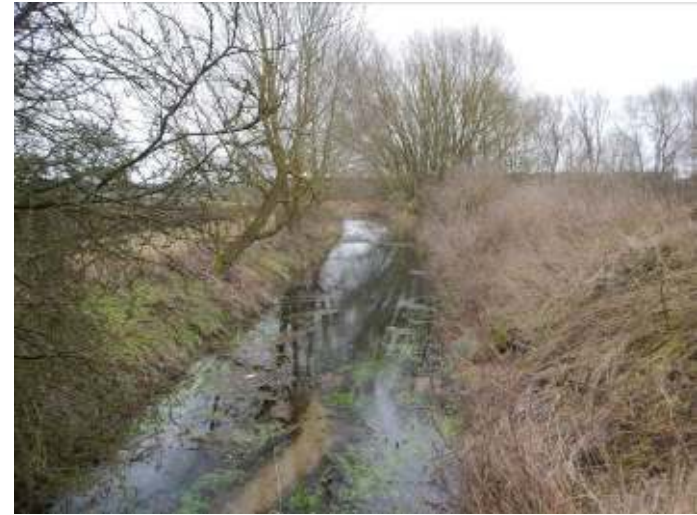
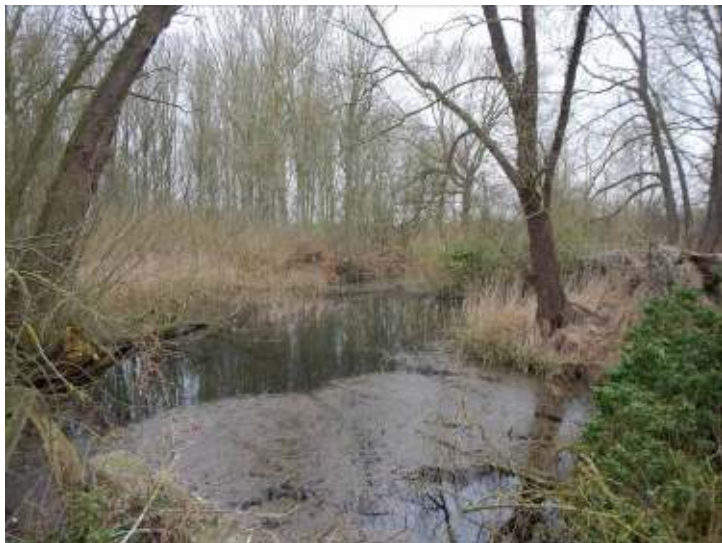
Identified opportunity	Grid ref	Scope	Constraints	Primary themes	WFD MM ⁶	BOMS ⁷	Figure no. in App. E
	improvement – tree planting along Fen Drain	05255 45453	reduce water temperature and increase habitats.	contributor	habitat improvement			
6	Proposed development to provide habitat creation	TF 05367 45833	Proposed development should be encouraged (under the National Planning Policy Framework 2012 ⁸) to incorporate wetland habitats along boundary with the River Slea, with opportunities for public rights of way and nature-focused events.	Development design – early engagement required	Wetland creation		✓	
7	Wet woodland creation	TF 05443 45729	Woodland with large pond and numerous ditches with fast flowing clean spring water. Opportunity to enhance as a wet woodland. contributing the wetland habitat mosaic. Water flows into Nine Foot River, possibility to divert to Slea during low flows. Woodland management required, fell large trees and use as woody debris/flow deflectors in Slea to enhance morphology and trap sediment. Add bat and bird boxes to trees. Bank re-profiling could be used to create a kingfisher nest bank in a private location to deter public disturbance.	Management, specialist design advice required	Wet woodland creation In-channel improvements	✓	✓	9, 10, 11

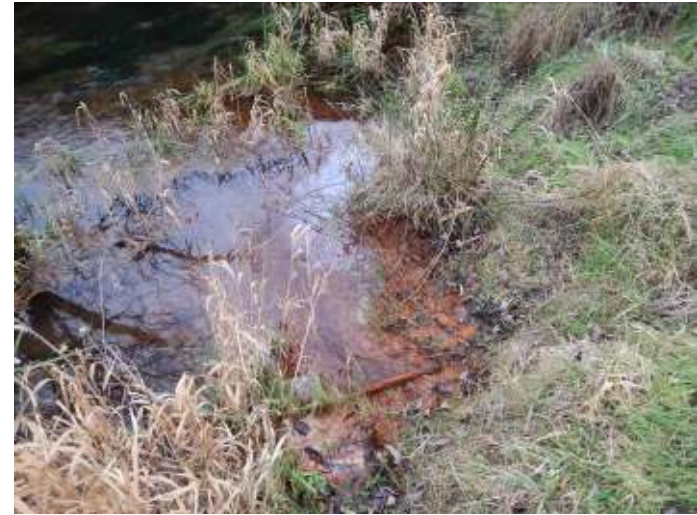
Figure 14

8	In-channel improvements – additional features	TF 05466 45829	The substrate was visible for much of the stretch, silt accumulated where the channel is wider and deeper. Use clean gravels to create better substrate with riffles; narrow channel with reed beds or woody debris deflectors to improve flow and trap sediment. Creates spawning habitat for trout/foraging habitat for elvers/eels. See Appendix G.	Maintaining capacity of flood water	In-channel improvements	✓	✓	12
9	Improving low flow resilience	TF 05565 45874	Sluice gate drains water from the Slea into Nine Foot River. Investigate the possibility to improve the seal of the sluice gate to prevent water loss from Slea during low flow.	Risk to Nine Foot drying out during low flows	Water quality improvements			13
10	Investigate potential pollution source	TF 05692	Ochre present in small quantity from field drain. Investigate effect on water quality. It may be naturally occurring in the soil,	Identifying source	Water quality improvements			14

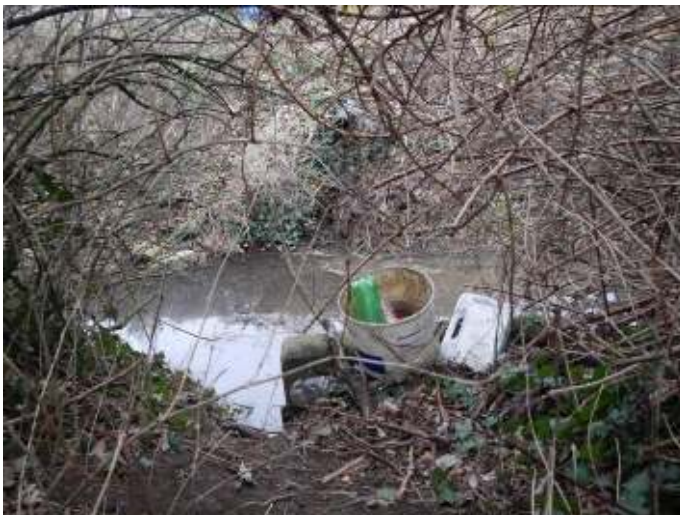
Figure 21

13	Investigate potential pollution source	TF 06062 45604	Field drain adjacent to railway embankment with evidence of ochre in the drain, requires water quality investigation. It may be naturally occurring in the soil, a marginal reed bed may improve water quality.	Identifying source	Water quality improvements			18
14	Improve water quality	TF 06036 45750	Stagnant ditch requires measures to improve flow and water quality. Land owner engagement to improve management.	Land owner agreement	Water quality improvements	✓		19
15	In-channel improvements – additional features	TF 06222 45785	Brick-lined channel – use vegetated coir rolls fixed to the wall to improve for biodiversity and amenity use. This could be extended from Electric Station Road to West Bank.		In-channel improvements, Amenity value	✓		20
16	Investigate potential pollution source	TF 06188 45818	Drain adjacent to Westgate Park, evidence of a water quality issue, water is stagnant, turbid and discoloured. Potential misconnections (waste pipe falls into rainwater drain) from residential park. Local engagement required to identify the source and create community scheme to enhance.	Identifying source	Water quality improvements, community engagement			21

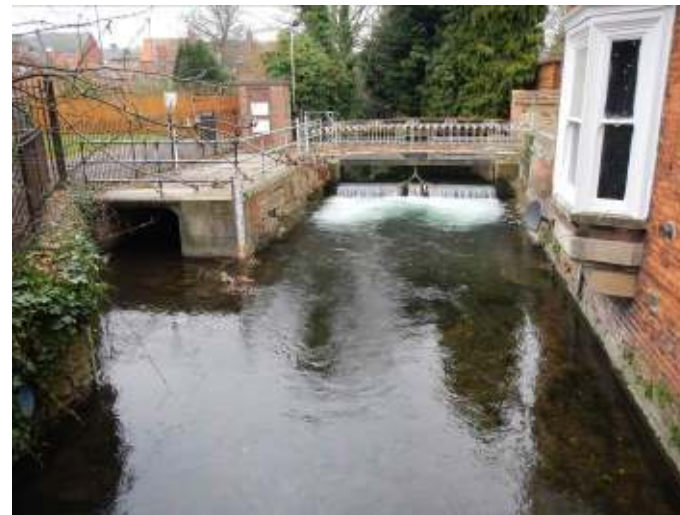
Figure 22 – upstream

17	Remove barrier to fish dispersal	TF 06898 45759	Remove Carre Street tilt gate which is a barrier to fish dispersal upstream. Improvement for brown trout / eel.	Financial, flood risk	In-channel improvements	✓	✓	22

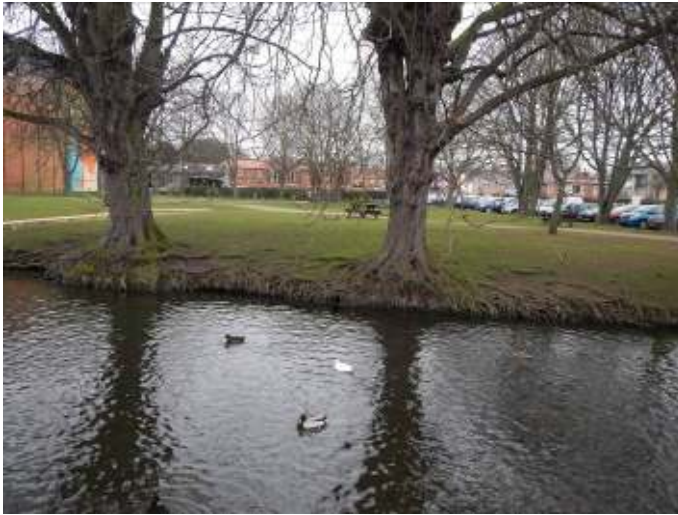
Figure 25

Identified opportunity	Grid ref	Scope	Constraints	Primary themes	WFD MM ⁶	BOMS ⁷	Figure no. in App. E
18	Improve water quality	TF 06495 45479	Drain surrounding Castle Fields is stagnant and discoloured. Water quality investigation required to identify cause. May improve silt issues downstream.	Identifying source	Water quality improvements			23
19	Meadow habitat creation	TF 06457 45552	Opportunity to enhance Castle Fields into a managed wildflower meadow. Currently used by dog walkers, fouling is a problem.	Management	Meadow habitat creation		✓	24
20	In-channel improvements – additional features Riparian habitat improvement – bank reprofiling	TF 07041 45742	River bank eroding by the slipway and new bridge, may contribute to increased silt downstream. Bank reprofiling required using faggot revetments and backfilling. Plant and use mesh to prevent ducks destroying veg until fully established. Alternative is to use seeded coir matting for longevity. Multiple benefits by narrowing channel, increasing flow, creating habitats and improve amenity value. See Appendix G.	Reduced flood capacity	In-channel improvements, Water quality improvements, Riverbank habitat improvement, amenity value	✓	✓	25

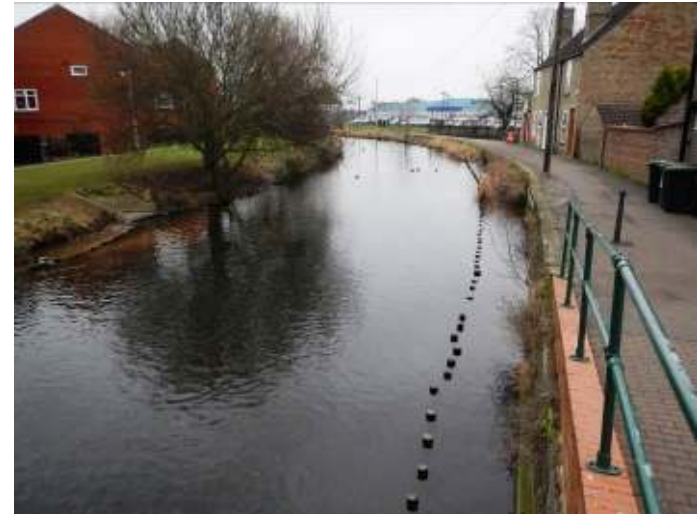
Figure 26 – downstream

21	In-channel improvements	TF 07231 45881	Enhance faggot revetment – requires backfilling and additional planting with mesh to prevent damage by ducks.		In-channel improvements	✓	✓	26
22	Wetland habitat improvement	TF 07230 45986	The Lollycocks LNR requires improved management. It can be enhanced through additional planting (hedgerow/tree screening along roadside), information sign-post, bird hides etc. Potential for flood storage if connected to Sleas. Anecdotal record of non-native fish species, eradicate to prevent spread into Sleas during flood and by birds such as grey heron.	Management	Wetland habitat creation		✓	27
23	Pest control issue	TF 07279 45945	Evidence of rats (burrows and droppings). Pest control may be required.	Financial Impact on other species such as water vole	Amenity value			28
24	In-channel improvement Remove barrier to fish dispersal	TF 07452 46102	Upstream of Coggleford Mill weir, the Sleas is too wide and flow is reduced. Evidence of vegetation removal, left on banks to rot, unsightly and can wash silt in river during heavy rain. Stricter management required. Maintain / increase reedbed to trap sediment. This will also improve habitats for birds, fish and	Maintain navigable route Financial	Water quality, In-channel improvement (brown trout / eel)	✓	✓	29, 30, 31

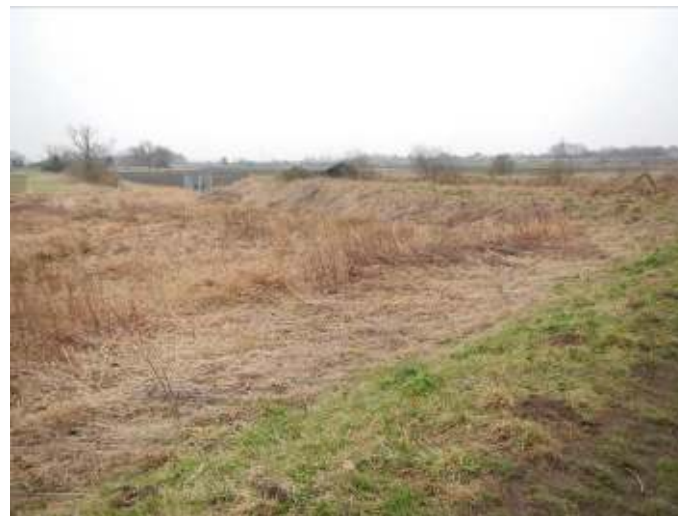
Figure 38

28	Riverbank improvements	TF 07748 46283	Stabilise the bank on the meander through riparian planting. This will also reduce any run-off from industrial estate.	Land ownership	Riverbank improvements, water quality	✓		35
29	Riverbank improvements	TF 07923 46502	Access road in industrial estate is very close to the river, a vegetated buffer strip would reduce any road run-off.	Land ownership	Riverbank improvements, water quality	✓		36
30	Water quality investigation Improving low flow resilience	TF 08043 46581	Large quantity of water lost at pumping station. Investigate potential to restrict pumping further during low flows.	Abstraction permit	Water quality			37
31	Wetland habitat creation	TF 08117 46629	Land next to pumping station is unmanaged and wet in places. Potential to create wetland habitat with flood storage benefits. Fish backwater / offline ponds. See Appendix G.	Land ownership	Wetland habitat creation, amenity value	✓	✓	38

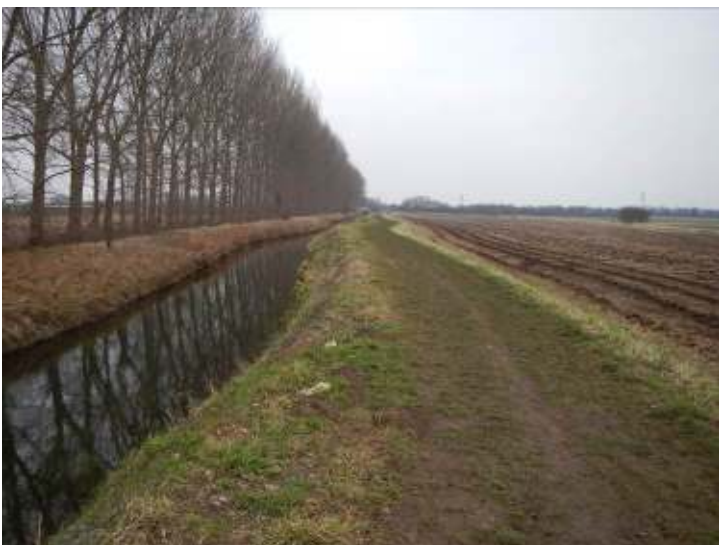
Figure 39– downstream

32	In-channel improvements – additional features	TF 08153 46718	This section of the Sleas resembles a canal with a straight channel, steep sided earth banks and minimal vegetation. To increase flow, trap sediment and increase habitat diversity, use woody debris deflectors to mimic meanders.	Land ownership	Riverbank improvements, water quality	✓	✓	39
