VERIFICATION REQUIREMENTS FOR GAS PROTECTION SYSTEMS

Technical Guidance for
Developers,
Landowners and
Consultants

Yorkshire and Lincolnshire
Pollution Advisory Group

Version 1.1 – December 2016

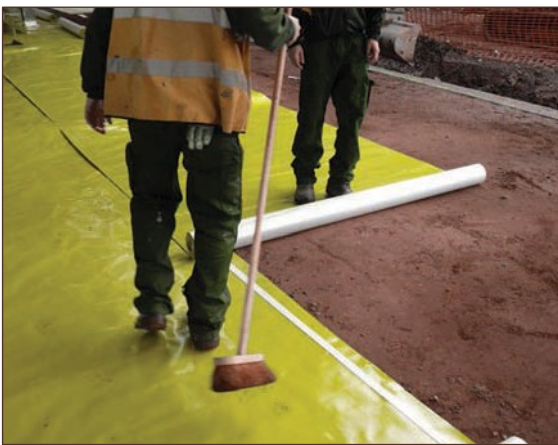
Figure A4.15 LDPE type gas membrane overlap and double sided tape. Sand blinding to protect underside of gas membrane (courtesy A Proctor Group)

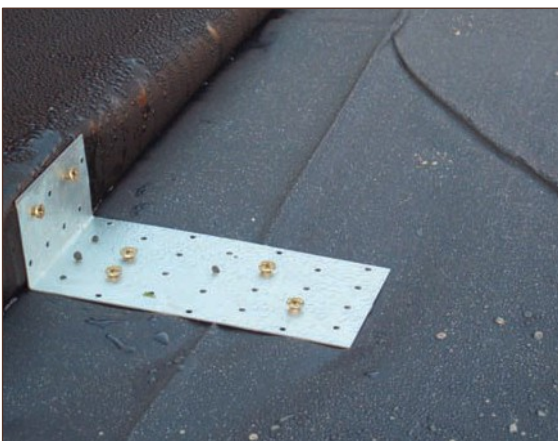
Figure A4.47 Follow-on works purposefully penetrating gas membrane (courtesy Card Geotechnics Limited)

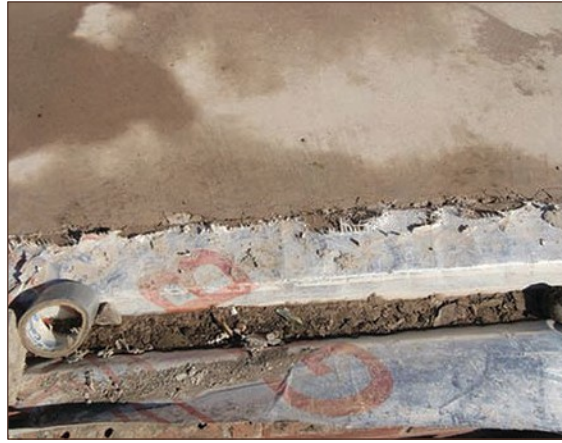
Figure A4.56 Gas membrane at edge of concrete screed. Screed has been grinded to achieve desired levels, gas membrane shows extreme wear and damage as a result (courtesy NHBC)

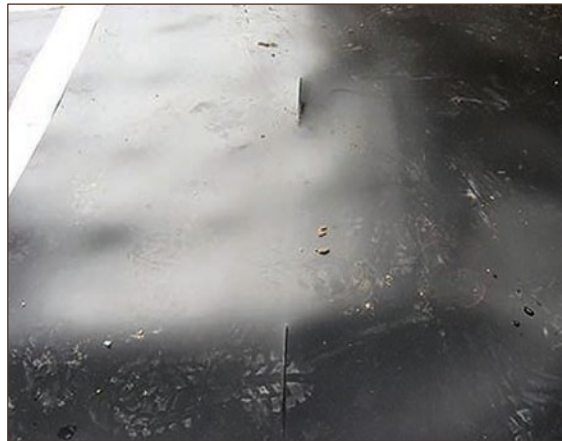
Figure A4.58 Damage caused to gas membrane by follow-on trade who cut/shaped the dry lining board directly on the unprotected installed gas membrane (courtesy NHBC)

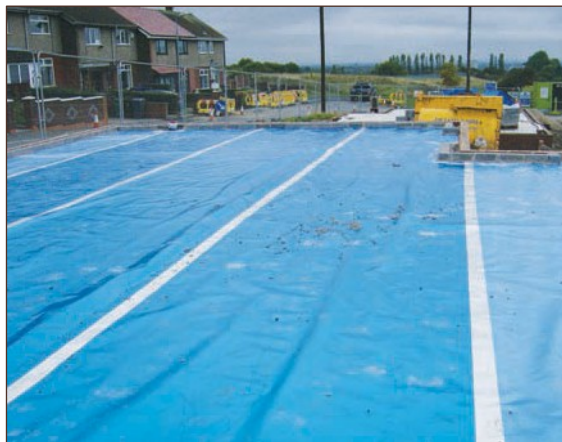
Figure A4.60 Some stones could penetrate gas membrane if sufficient force is applied (courtesy Smith Grant)

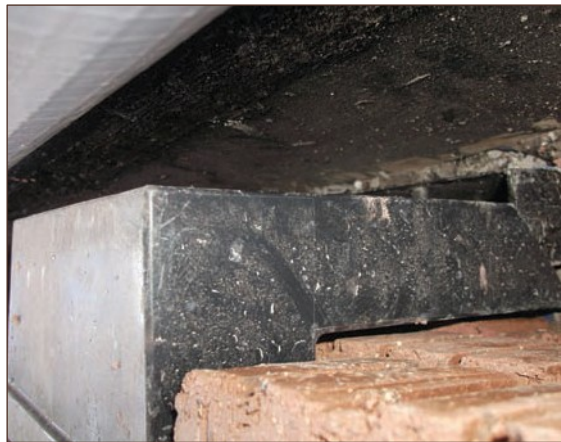
Figure A4.88 Ventilator becoming detached to fit to external block work. This is due to builders requiring increased cavity widths to achieve thermal properties expected by Building Regulations (courtesy NHBC)

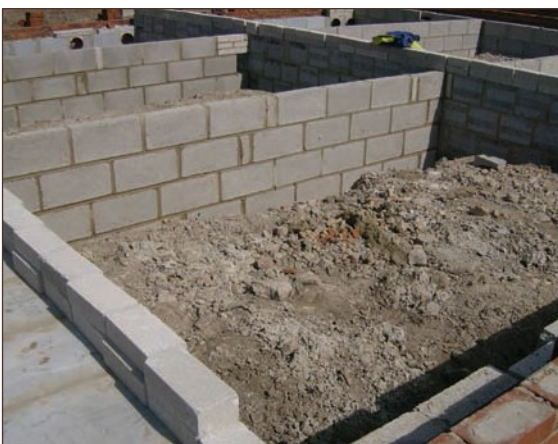
Figure A4.89 No ventilation in internal sleeper wall (courtesy Smith Grant)
