# Billingham Conservation Area

NORTH  
KESTEVEN  
DISTRICT  
COUNCIL

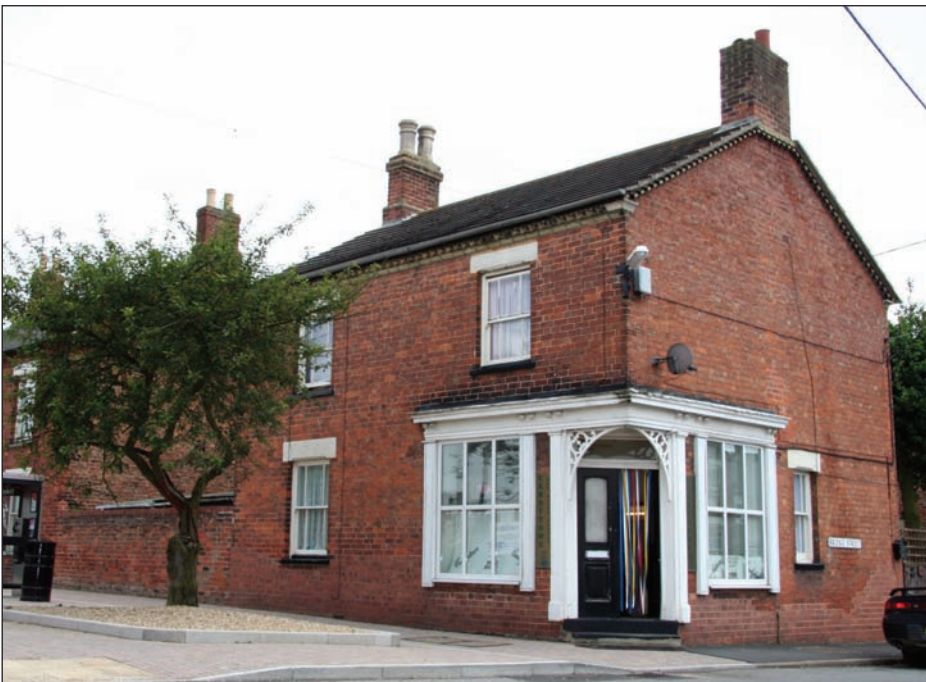
▼  
*14 Bridge Street has features typical of the buildings in the Conservation Area; a shop front with a corner door, margin light sash windows and brick decoration along the eaves and the gable verges.*

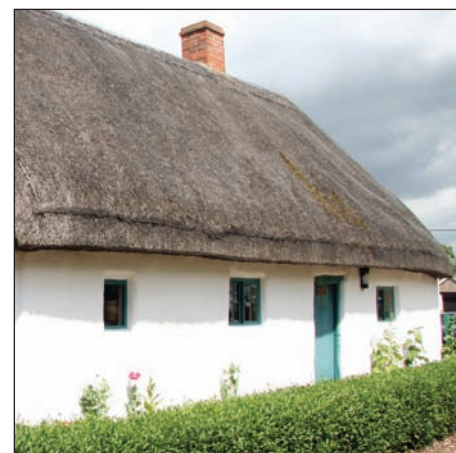
▲ The Old Vicarage is a Grade II listed building and dates from the middle of the C17. The front wall is mud and stud, the traditional Lincolnshire vernacular building material, along with a thatched roof, for cottages of the C16 to C18.

Apart from the Parish Church the earliest surviving building within the village is the Old Vicarage. This is of the Lincolnshire vernacular design, 'Mud and Stud', and dates from about 1650. Some of the village buildings date from the C18. These include 22 Victoria Street and 48 West Street, the latter outside of the Conservation Area. By the early C19 the village was largely constrained between the Tattershall Road, West Street/Church Street, Fen Road and High Street.

Former dwelling, now office and visitor attraction, mid C17. Mud and stud east wall, with the others being of C18 brick. Half hipped thatched roof. Late C18 brick and pantile extension to south. Baffle entry. Sold 1734 when a replacement vicarage was built nearby. Restored 1989. An example of the traditional vernacular building style common in Lincolnshire in the C17 and C18.

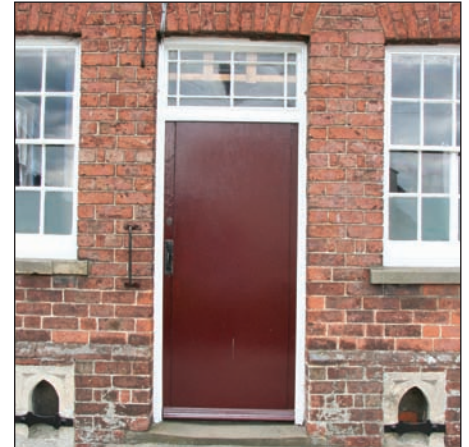
▲ *The mid C19 door to the Baptist Chapel. Over the door is a margin light fanlight, a feature found on other buildings of similar date in the village.*

Some higher status buildings have central front doors, often within a doorcase, and with a fanlight over. The most common form of fanlight is a margin light sash. This can be found on the Baptist Chapel, 14 Bridge Street, 9 High Street and 14 Victoria Street.

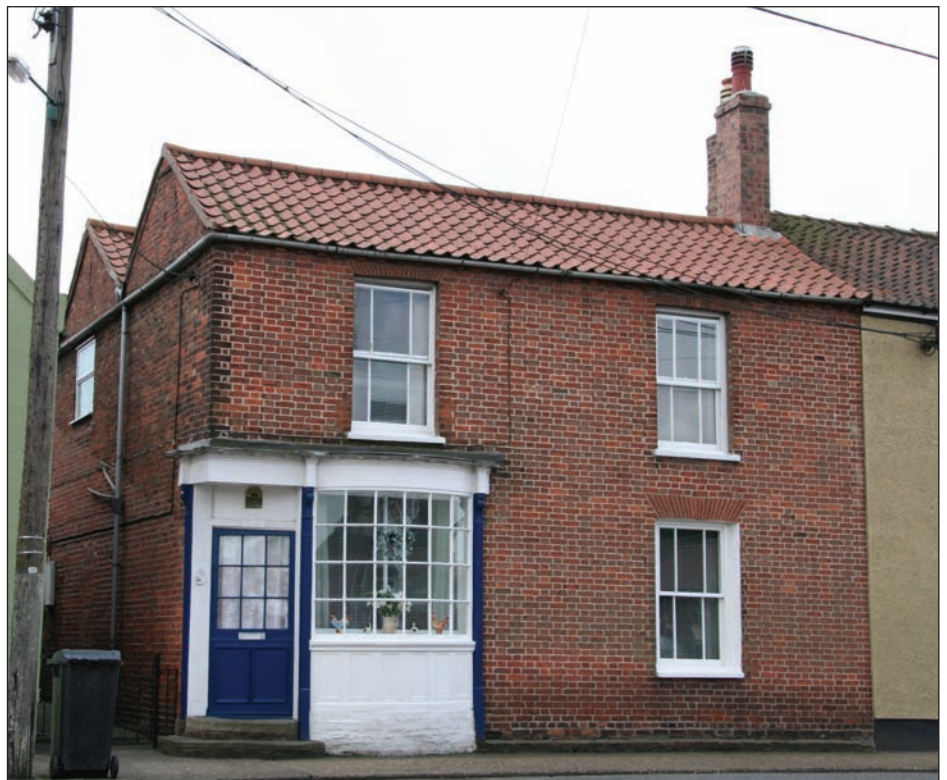
▼ *17 Victoria Street is a Grade II listed building. The corner door to the former shop and the margin light sash windows are typical of the Conservation Area.*

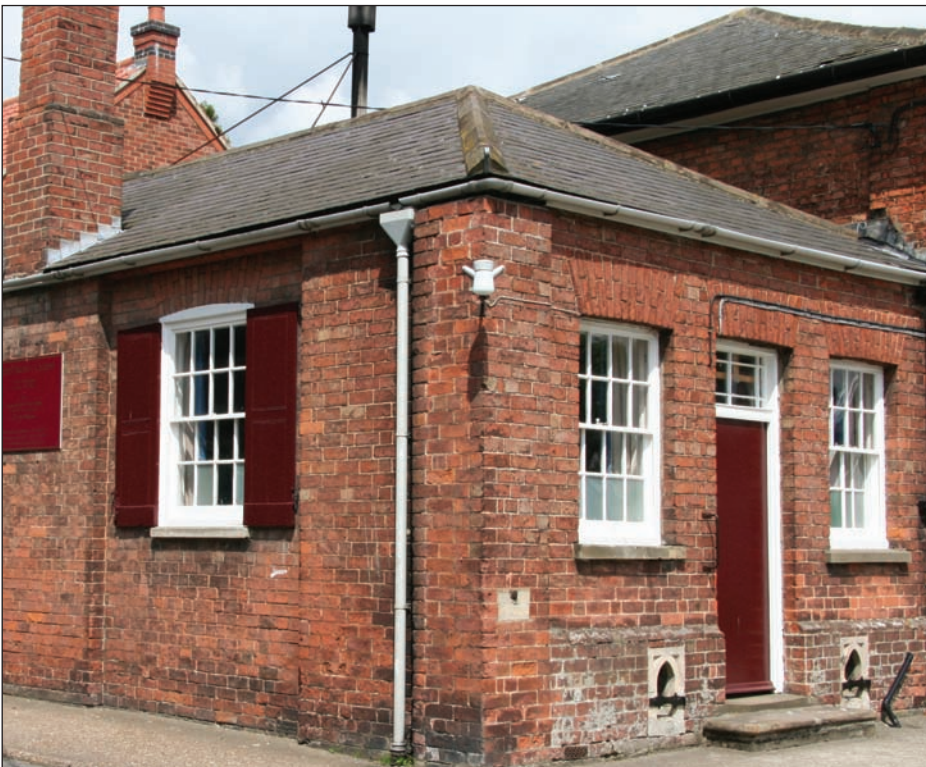
▼ *The front wing of the Baptist Chapel is an extension of the mid C19 to the earlier Chapel behind. The sash windows retain their original shutters, a rare survival.*

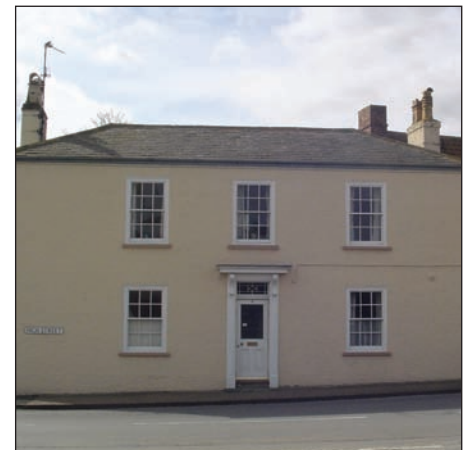
▲ *9 High Street is typical of the mid C19. The small pane sash windows and the door with its frame, hood and fanlight are particularly notable.*

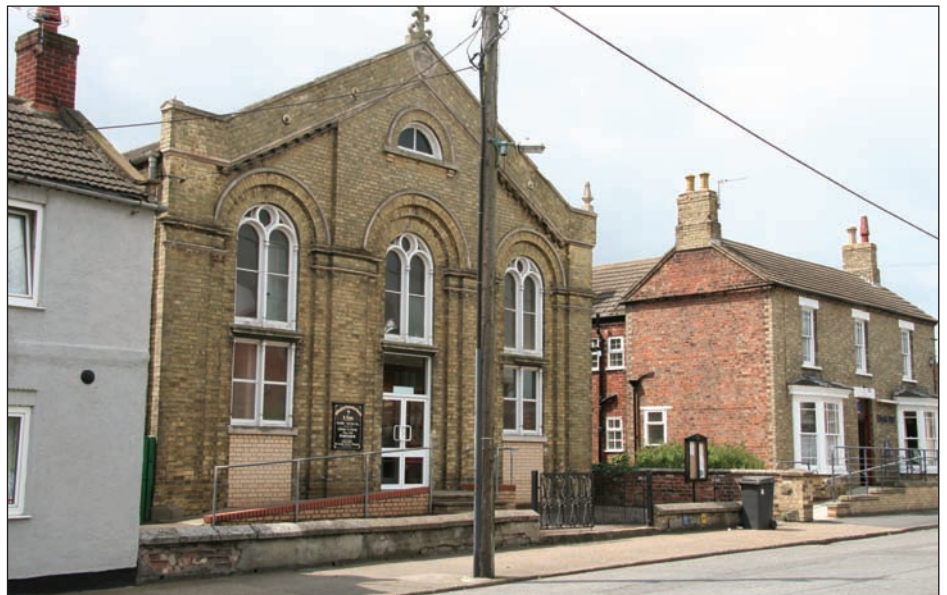
▼ 2761. The Methodist Church was built in 1869 around the same time as 35 Victoria Street on the right. The front walls are built in yellow brick. They are within the area devastated by fire in 1864.

The palette of materials that help to create the character and appearance of the buildings is of a red or brown brick, and occasionally yellow brick, for walls and chimneys and details such as eaves and verge dentillation. Roofs are of natural clay pantiles for cottages and blue slate, or pantiles with a raised brick gable, for higher status buildings. Examples of buildings with raised gables are 15 Victoria Street and the Methodist Church.

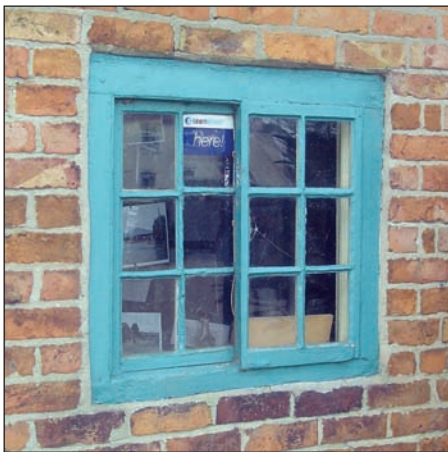
▲ A Yorkshire sliding sash window at The Old Vicarage on Church Street.

Windows are generally of timber and taller than they are wide. Vertical sliding sashes are common, often plain panes with margin lights. Small pane sashes dating up to the early C19 and plain sashes dating from the late C19, can also be found. The Yorkshire Sash, sliding horizontally, can still be found but is now rare in the Conservation Area. This, especially in its three section form, is wider than it is deep. Windows are set back slightly from the face of the wall and this, together with the step in the traditional sash window forms brings relief to the facades of buildings.

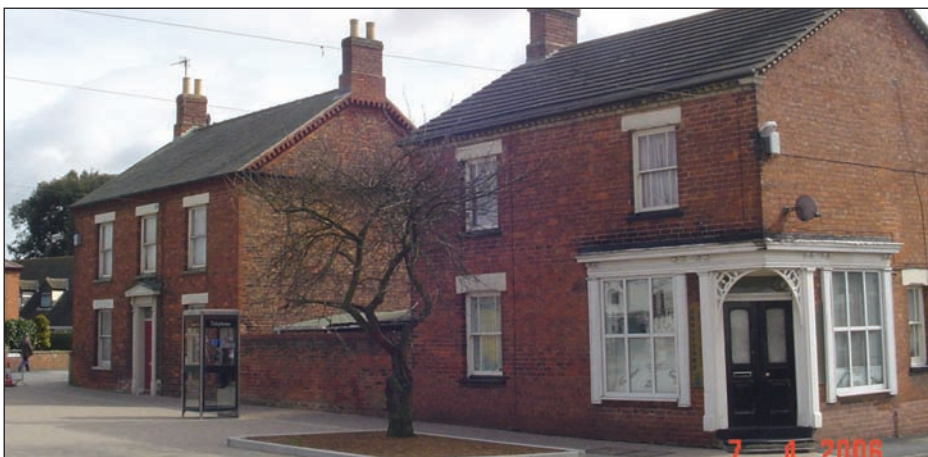
▼ . 1 Church Street, on the left, and 22 Bridge Street, right, enclose the east side of the Market Place. They are both fine examples of buildings of the late C19 and their detailing, including their sash windows, stone window heads, the doorway to 1 and the shopfront to 22, and their decorated brick coursing at the eaves and gable verges are evidence of the wealth of the village at that time. Note that the windows are set back slightly from the face of the building and how this adds interest to their appearance.

The prevalent local building material is brick for walls. This is, in the main, a red or brown brick with some yellow brick introduced from the late C19. Some buildings, from the late C18 through to the mid C19, have raised, brick coped, gables. The only building of stone is the Parish Church. Several houses dating from the late C19 have dentillated brick courses at the eaves and verge. 1 Church Street and 22 Bridge Street are examples.

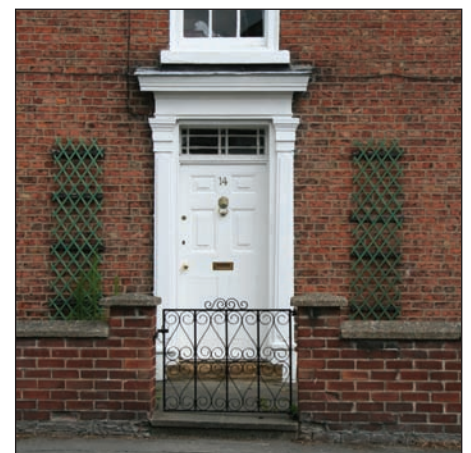
▲ 2765. 14 Bridge Street has a fine entrance door with a margin light fanlight over, a feature typical of buildings of the early C19 in the village.

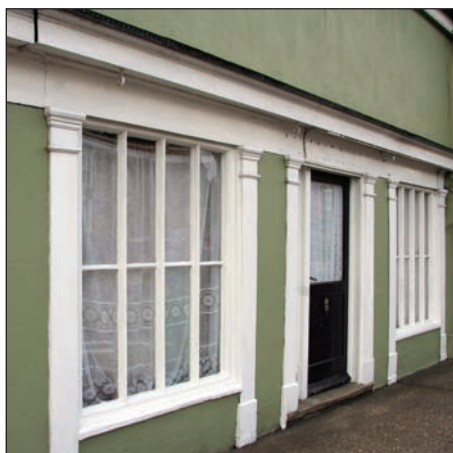
▲ 13 Victoria Street retains a fine example of a mid C19 shop front.

Shopfronts are a feature of the Conservation Area, both to existing and former shops. Many retain original timber shop windows and doors, the corner door, in particular, being a feature of the village, both inside and outside the Conservation Area. 22 Bridge Street retains its corner door with a distinctive design of supporting bracket over.
